SVERIGES GEOLOGISKA UNDERSÖKNING

SERIE C NR 772 AVHANDLINGAR OCH UPPSATSER ARSBOK 73 NR 13

ÅKE HILLEFORS

THE LANDSLIDE AT GUNNILSE  
IN THE LÄRJE VALLEY  
WESTERN SWEDEN

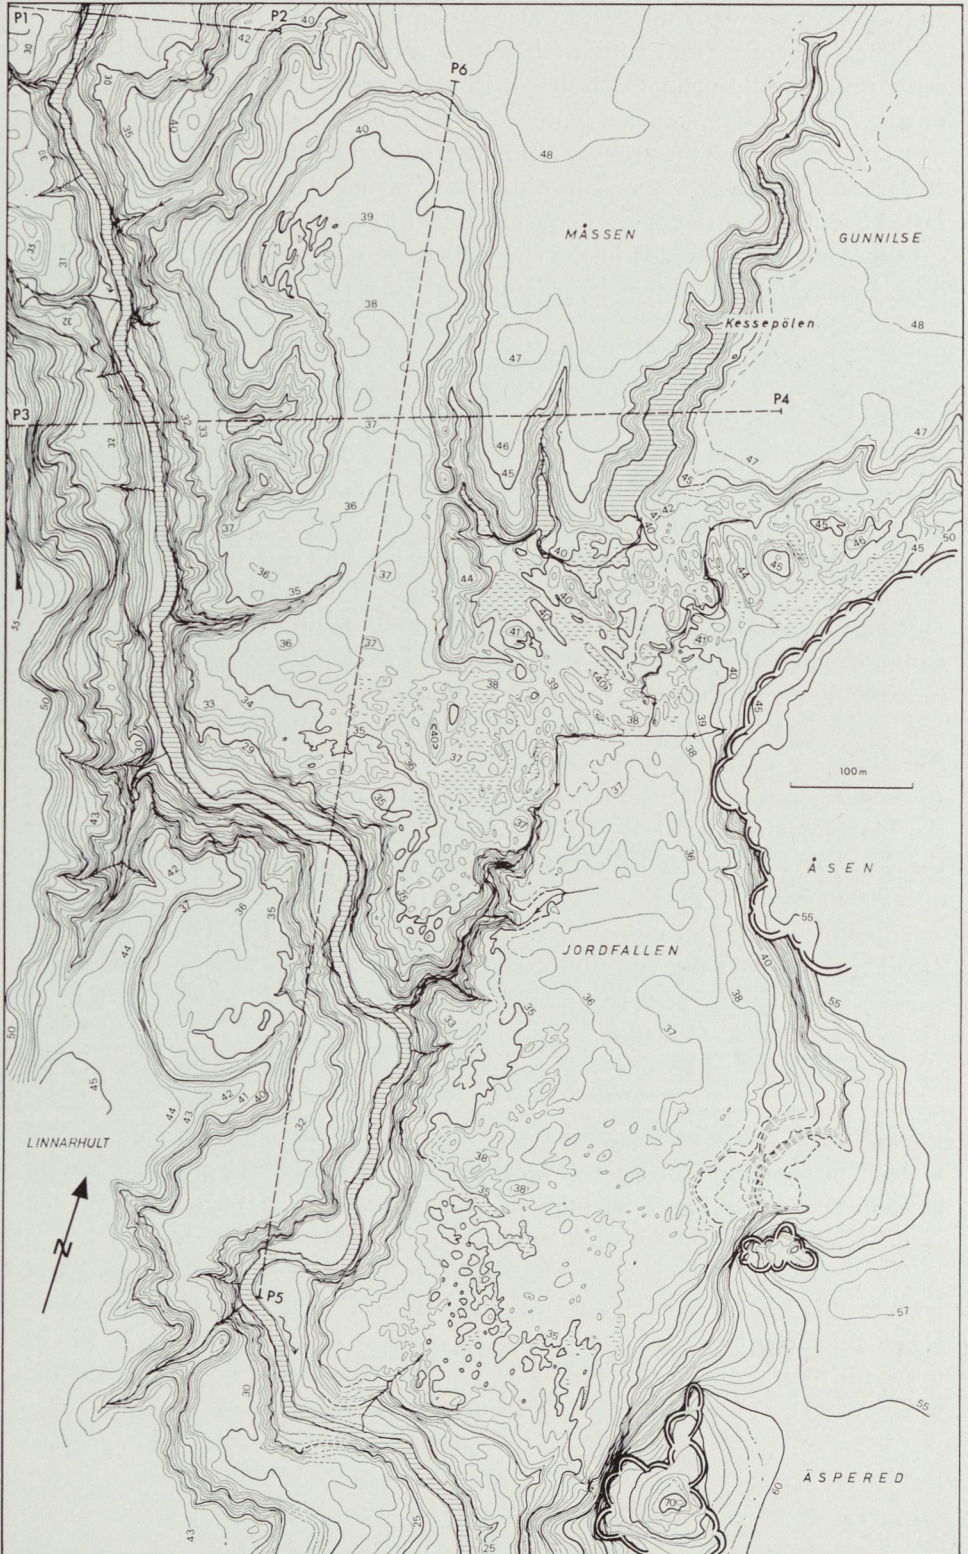
Fig. 3. Map of the landslide at Gunnilse showing its morphology. Equidistance 1 m. Profiles (see Fig. 4) have been marked. The even ground contrasts to the ground characterized by tilted blocks of the old dry crust with ponds and bogs in between (dashed area). (The dotted lines in the southeastern Jordfallen area — just around the foot of the slide scar — mark a dumping-ground.)

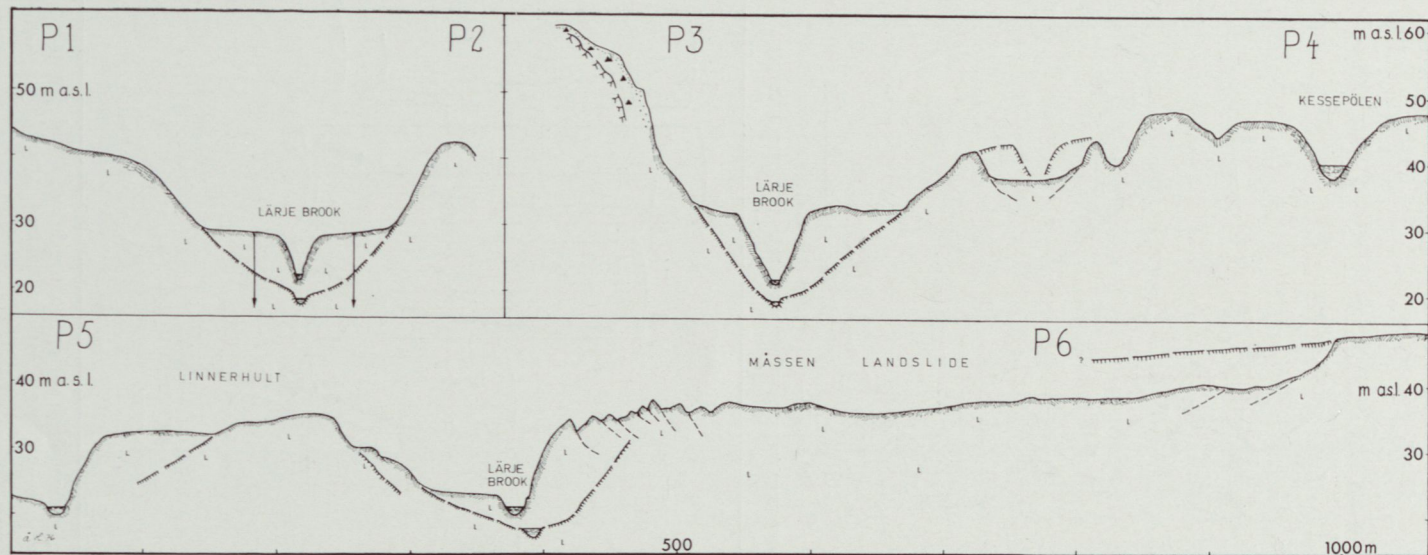
Fig. 4. Profiles. P1—P2 across the Lärje stream with two borings revealing the old land surface and the reconstructed stream position (L = clay). P3—P4 from the Linnarhult rock hill slope in the W (with an accumulation of till on its surface) to the clay terrace at about 32 m in the stream channel and to the E of the large, dammed gully with the pond named Kessepölen. Toothed lines show hypothetical old land surfaces. In the middle of the profile and to the right of it, the actual landslide area. To the right the bowl with the presumed old land surface (toothed lines) and slip surfaces (dashed lines); the out-slidened and upthrust clay nappes in the middle.

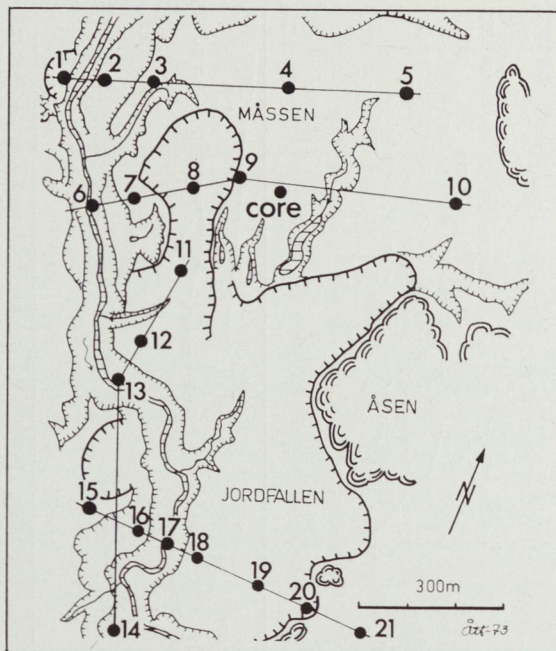
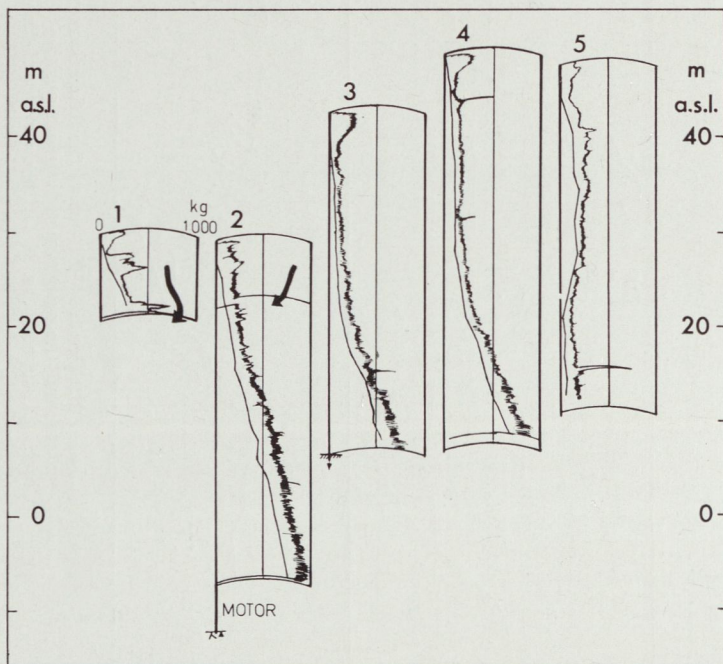
Fig. 5.a. Map of the geotechnical borings in the Måssen and Jordfallen areas. The diagrams shown in Figs. 5 b–e are marked by numbers, the Måssen diagram in Fig. 6 by "core".

Fig. 5.b. Diagrams of the borings along the northernmost profile in Fig. 5a. The jagged lines show the total force and the lines close to the left the friction to the mantle of the borer. The intervals between these curves mark the resistance to the point of the borer.

The high shear strength of the dry crust appears clearly. Below this crust there is a clay layer which is obviously very loose. Single laminae and layers of silt and sand appear as peaks. The arrows in diagrams 1 and 2 mark the probable old stream channel bottom and land surface, now covered by quick clay.

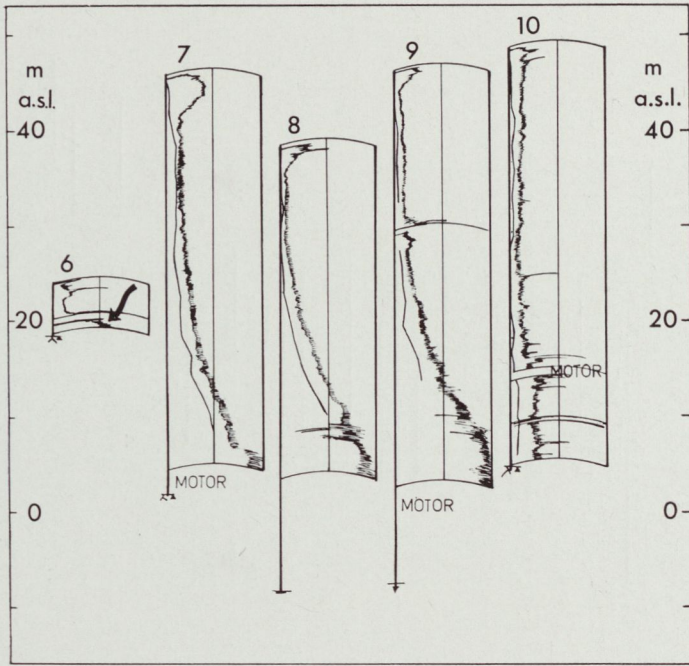
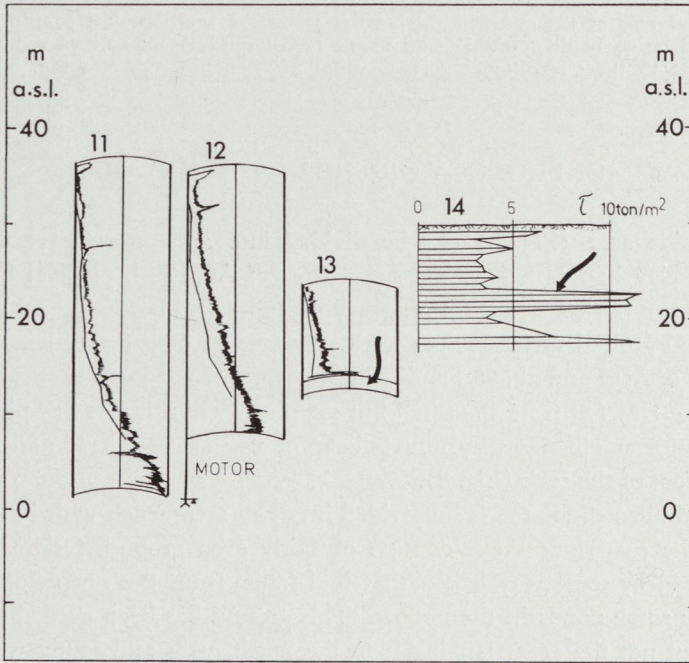
Fig. 5.c. Diagrams of the geotechnical borings along a northerly profile in Fig. 5a. The toothed curve in the deeper layers (diagram 10) might reveal sand layers and varved glacial clay situated close to the glaciofluvial accumulations at Asen hill. Cf. also Fig. 5 b: the explanations.

Fig. 5.d. Diagrams of the borings along the N—S profile in Fig. 5a. Diagram 14 is a vane test. Cf. also Fig. 5 b: the explanations.

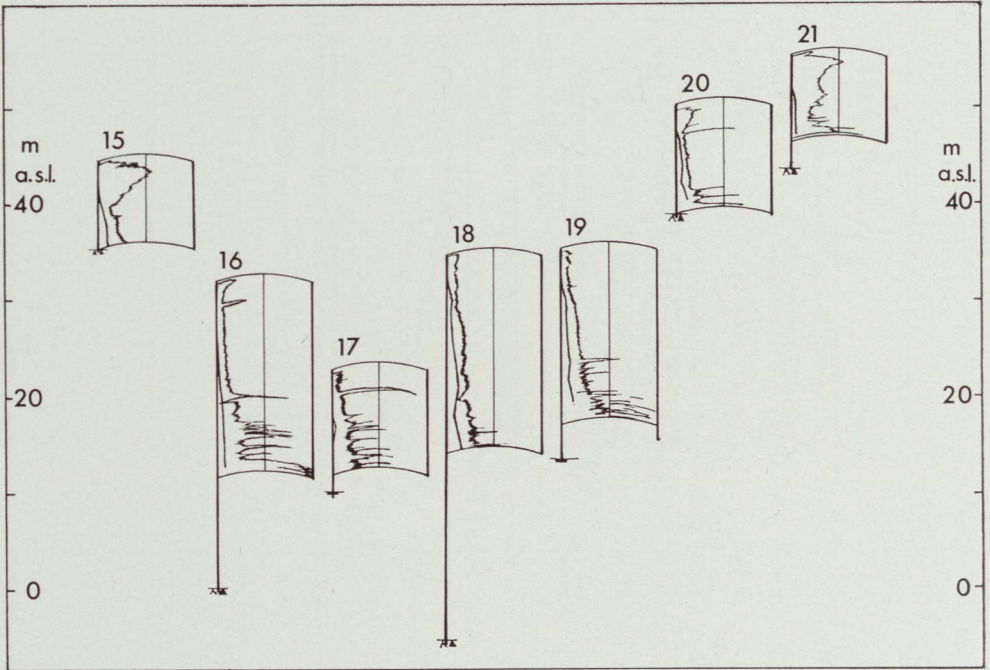
Fig. 5.e. Diagrams of the geotechnical borings along the southernmost profile in Fig. 5a. The toothed curve in diagrams 19—20 might reveal sand layers and varved glacial clay situated close to the glaciofluvial accumulations at Åsen hill. Cf. also Fig. 5 b: the explanations.

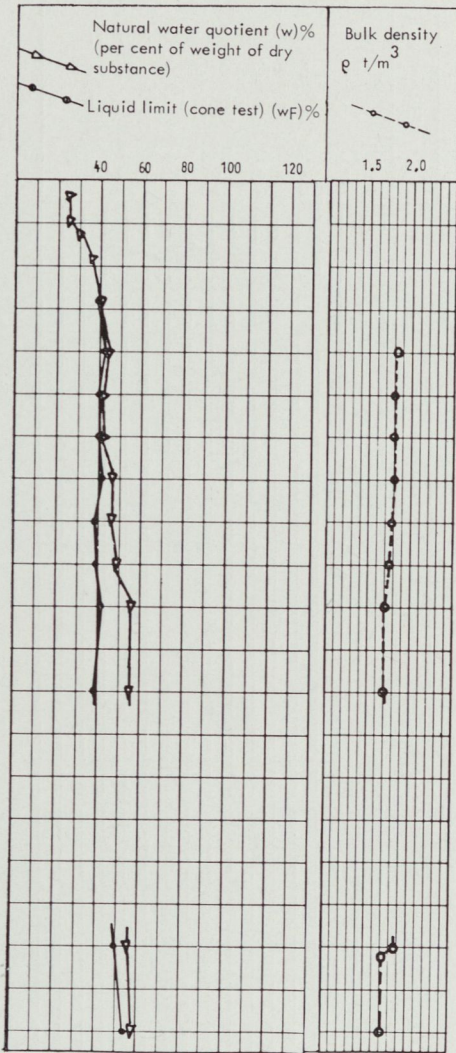
Fig. 6. Geotechnical diagram of the boring to the E of the Mässen landslide area (for the locality see Fig. 5 "core"). The samples from 14 and 16 metres fell out of the borer as the clay apparently was remoulded at the boring and thereby liquified. The "gap" between the two curves showing the natural water quotient and the liquid limit (cone test) is typical of quick clays.

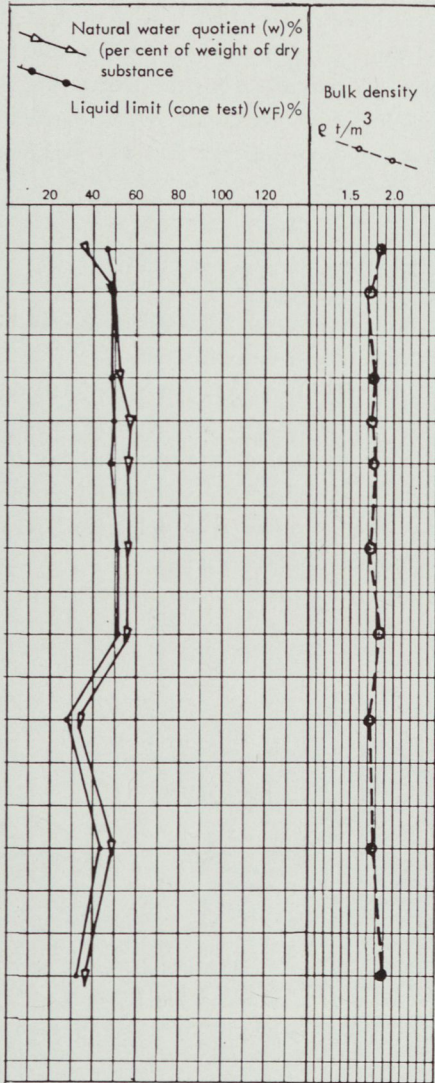
Fig. 7. Geotechnical diagram of the boring 18 (see the map Fig. 5). Below the dry crust there is a layer of highly sensitive clay. The "gap" between the two curves, showing the natural water quotient and the liquid limit (cone test), is widest where the clay layers with the highest sensitivity are found. — Characteristic of the clay in this boring are the silt laminae.

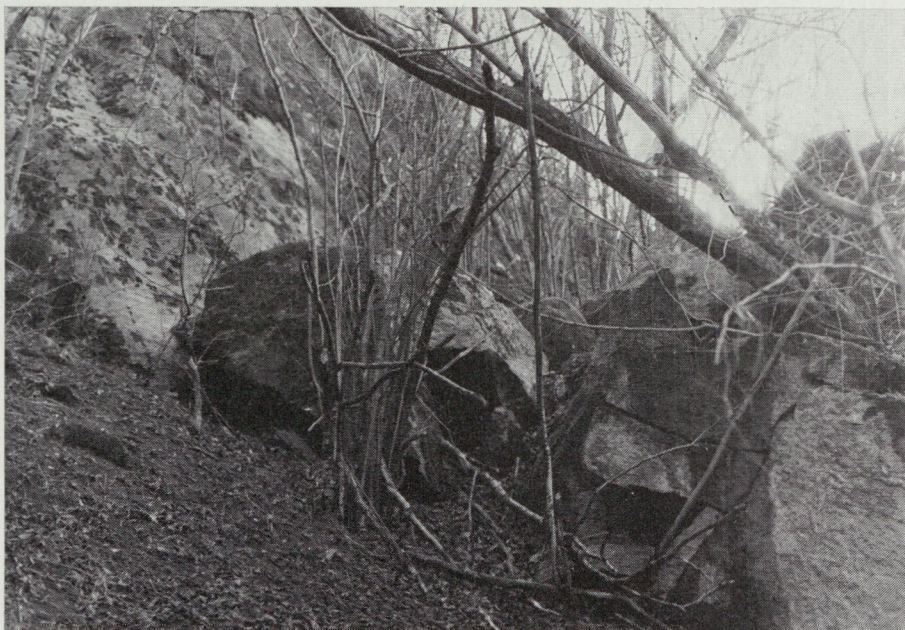
When the clay fell from the small but steep rocky hills in the SE, pieces of the rock also loosened. Today they form a heap of angular boulders in all about 200 m<sup>3</sup> at the foot of the rock (Fig. 8).

Fig. 8. Large boulders, which probably slid down when the clay fell out from the steep slope in the southernmost part of the Gunnilse landslide. The scar in this rock slope has not been completely covered by lichens, so it does not seem very likely that frost is responsible for recent shattering of the rock.

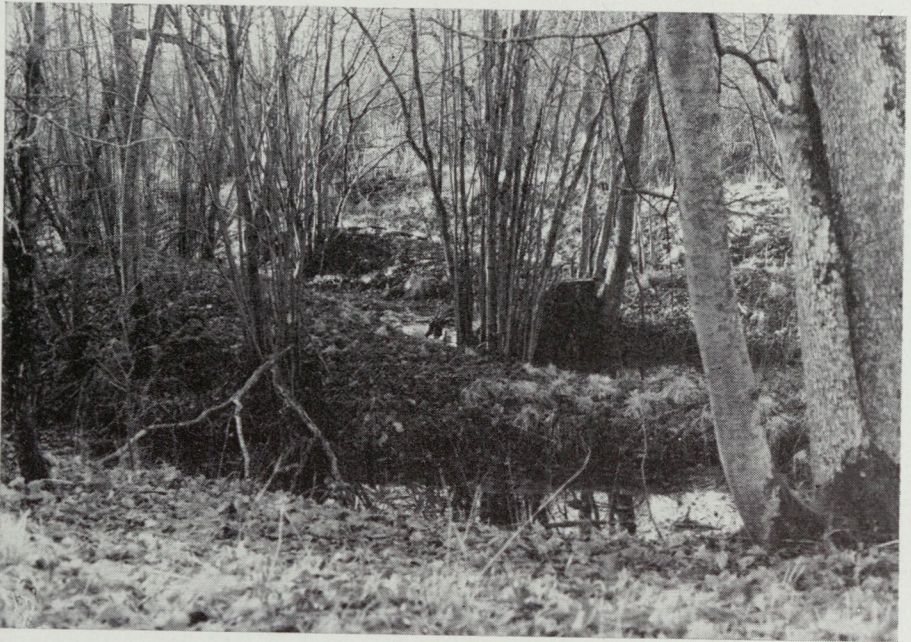
Fig. 9. Clay nappes of dry crust rise over elongated ponds and swampy grounds. A rich grove vegetation has developed. The southern part of the Gunnilse landslide.

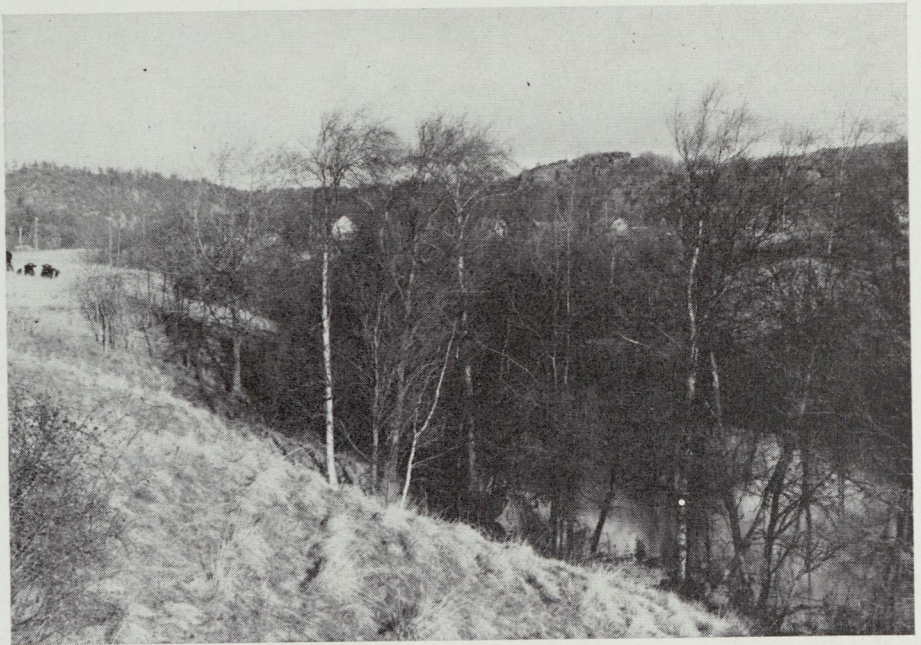
Fig. 10. The dammed gully and the winding pond Kesepölen. To the left the clay-terrace surface. In the background the rocks with steep slopes down to the marine clay on the bottom of the joint valley.

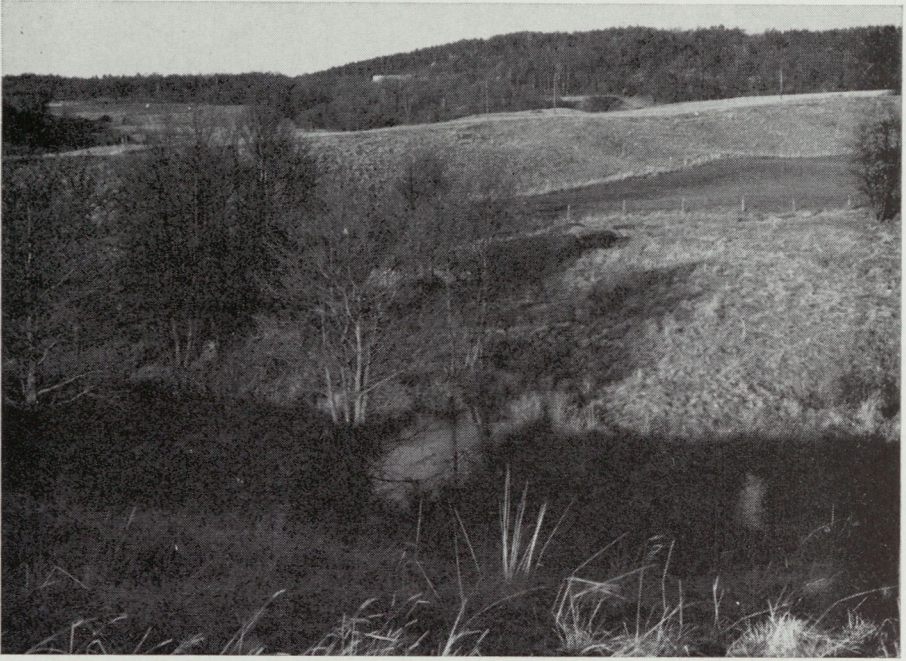
Fig. 11. The western part of the bowl of the bottleformed Måssen landslide and the proximal part of it. Some back-tilted and slumped clay nappes are visible and small elongated ponds in between them. In the background the southern edge of the Vättlefjäll rock plateau, bordering the Lärje joint valley.

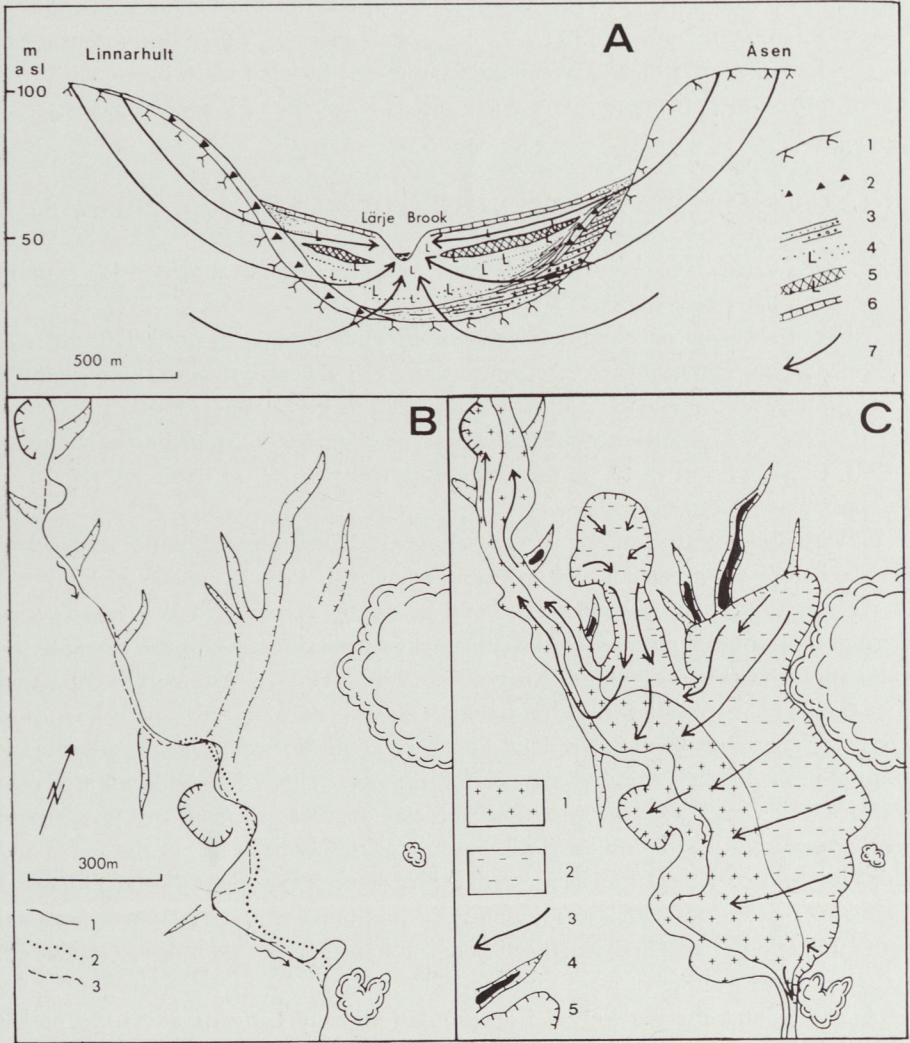
Fig. 13. A. Sketch of a cross-section of the Lärje valley between Åsen and Linnarhult. 1 = rock; 2 = till; 3 = sand and gravel (glacial lee-side deposit); 4 = marine clay with laminae of fine sand; 5 = layers of quick clay; 6 = dry crust; 7 = hypothetic ground-water flow trajectories.

B. The Gunnilse area before the slide — a reconstruction. 1 = the pre-landslide stream channel (according to Kruse's map, 1731); 2 = stream channel over the landslide area after the lake, dammed by downslidden clay, was emptied (also according to Kruse's map, 1731); 3 = the stream channel today; 4 = gullies, existing and — in the landslide area — hypothetic; it is very probable that there was at least one gully in the Jordfallen area before the slide.

The releasing cause of the landslide was most probably that a slump occurred in the eastern stream bank in one of the bends in the southern part of the Jordfallen area, where the Linnarhult landslide had happened previously. Then the stresses finally exceeded the shear strength of the clay. A cylindrical slide layer was then formed in the quick clay, probably about 7–10 m below the ground surface. This depth has been estimated from observations in other quick clay landslides in Norway in particular and from the geotechnical borings at Gunnilse.

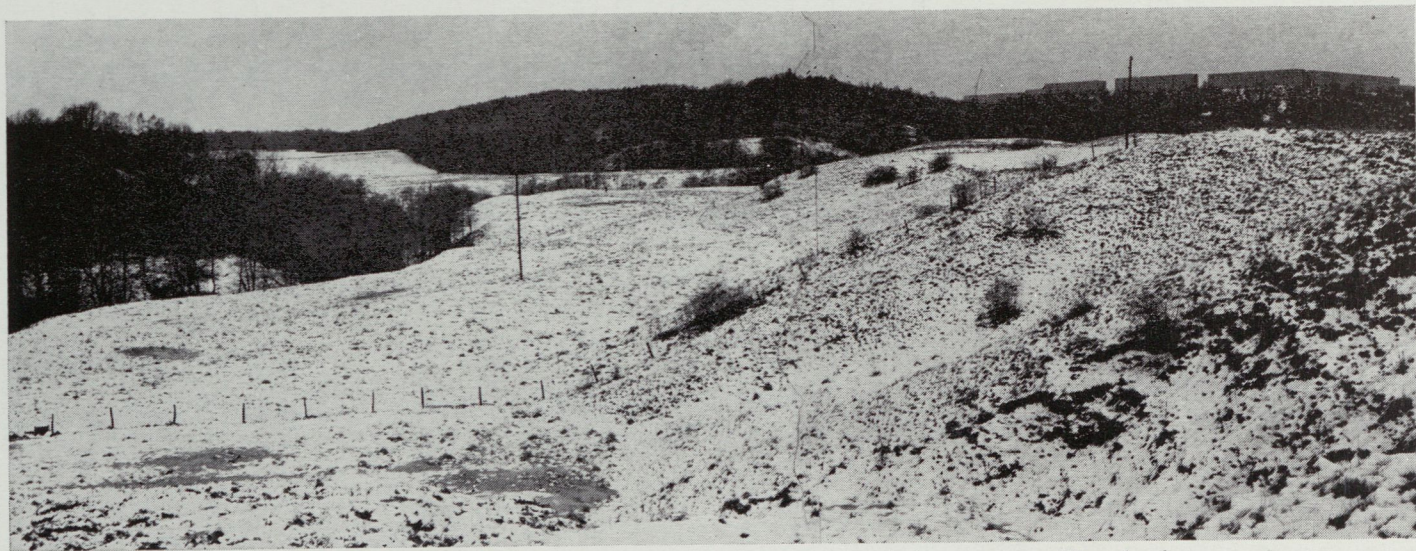
Fig. 14. The gully slope close to the Lärje stream (left) and the terrace at 33 m level. This gully slope was very wet from ground-water seepage during the snowmelt season in 1973 and small slides of clay knolls were observed. View from the gully slope to the NW of the Måssen landslide and towards the NNE.

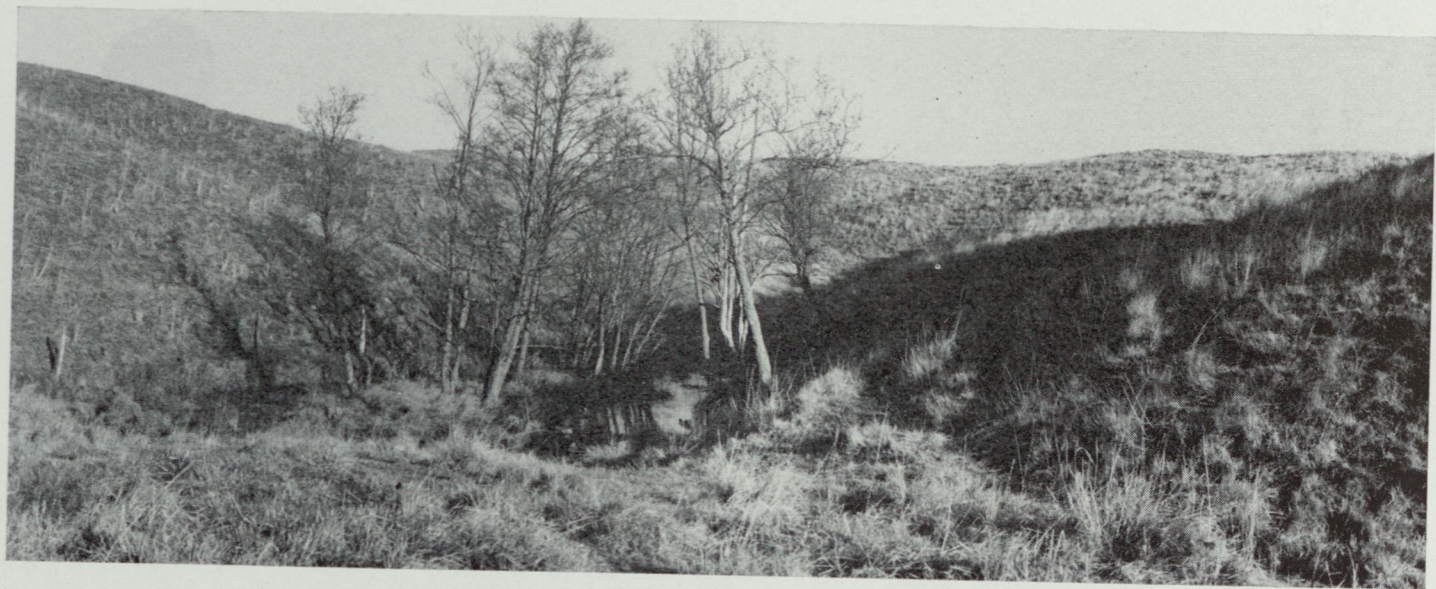
Fig. 15. A gully close to the western part of the Måssen landslide. It was dammed by the quick clay that flowed upstream the channel from the Måssen area and now forms a terrace bulge in front of the gully.

In recent years minor landslides and slumps have occurred on the steep slopes of the gullies and the stream channel (Figs 15 and 16). Solifluction and soil creep are active. During the winter, the frost reaches a depth of 1—1.5 metres. Due to the freeze-thaw process, blocks of the dry crust are dislodged and gra-

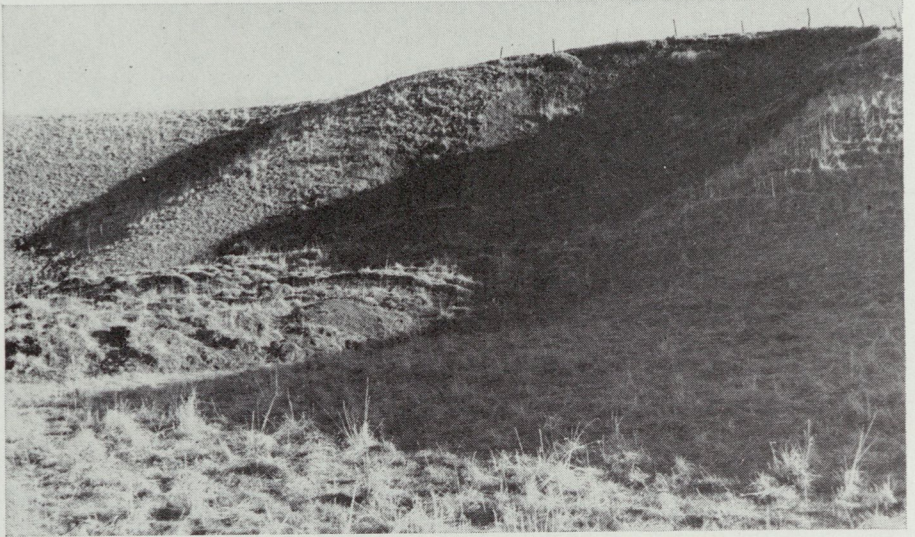
Fig. 16. A recent small landslide in a steep clay gully slope to the NW of the bottle-formed Måssen slide scar.

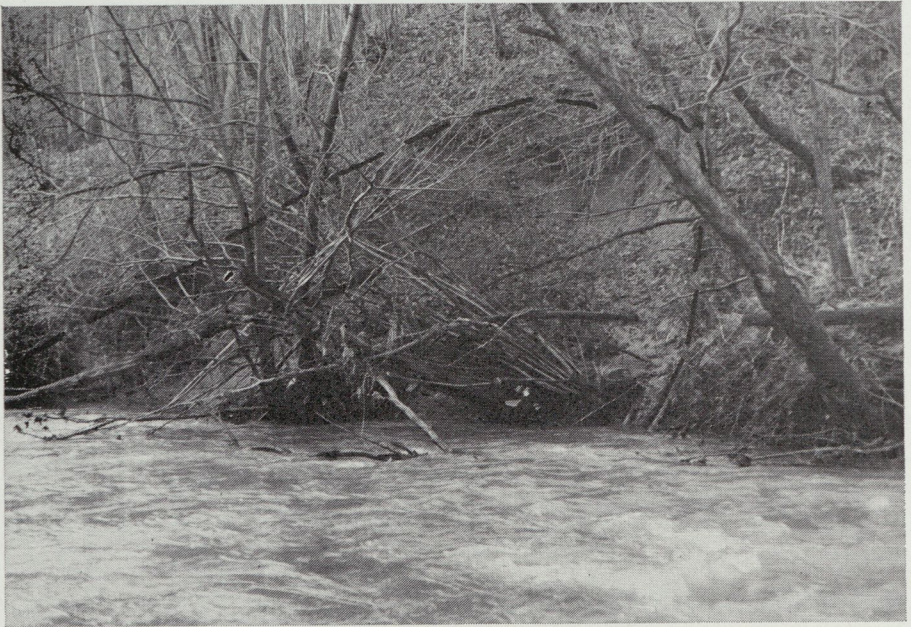
Fig. 17. The Lärje stream flows fairly swiftly through the clay masses that once dammed its channel. The standing waves reveal that boulders, washed out from the clay, have formed a pavement on the stream bottom. A fresh clay fall in the bank is visible. Several slumps of this kind appear along the channel banks.

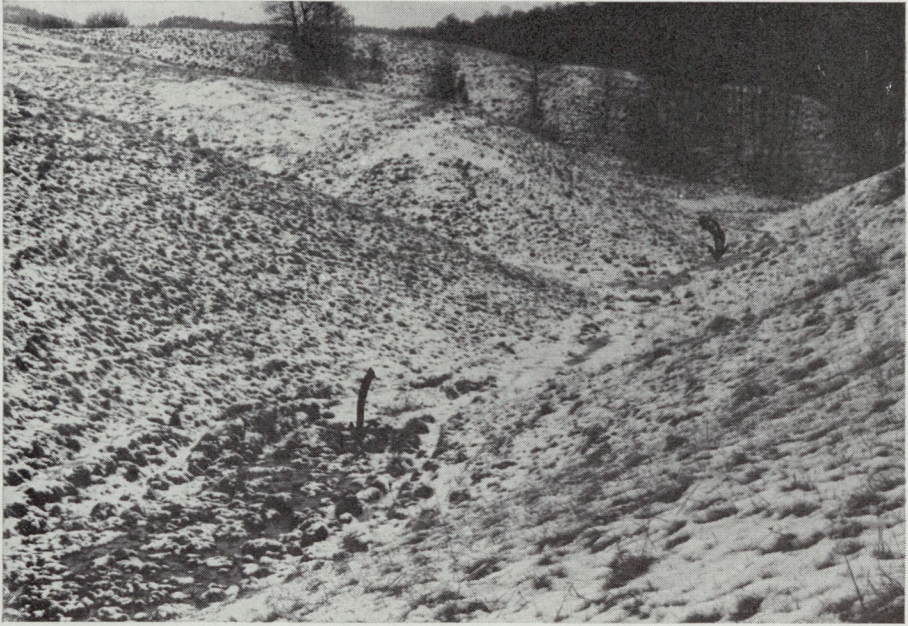
Fig. 18. The gully slopes to the W of the Måssen landslide with many tussocks of *Deschampsia caespitosa* and *Juncus conglomeratus* (at the bottom). The gully bottom is filled with mould and clay which have been washed down. This material makes up a swamp (left) which drains into a sinkhole (the nearest arrow) in the clay. Then the water flows into a subterranean channel, the mouth of which is visible at the furthest arrow.

Some species of grass, i.a. *Deschampsia caespitosa* and sedges such as *Juncus conglomeratus* form tussocks in the gully area. These tussocks freeze more easily during the winter and dry up more easily than the surrounding ground. Consequently they become cracked and rifted and the soils are exposed to splash erosion. Naked soil stripes are therefore rather often seen from such grass tussocks in different stages of disintegration (Figs 18 and 19).

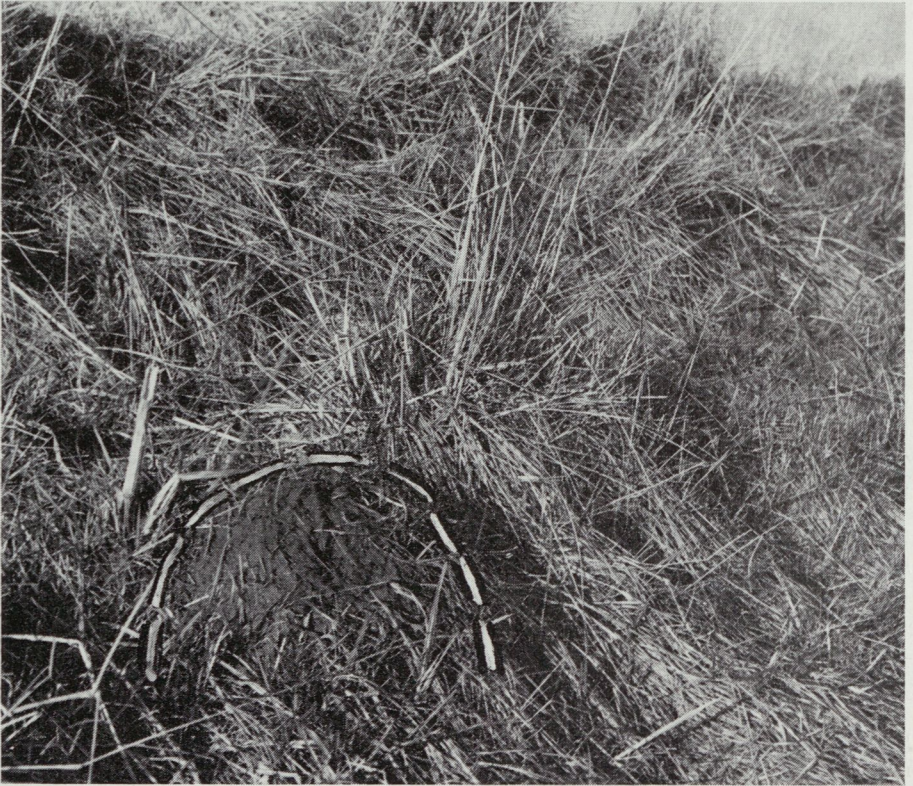
Fig. 19. A tussock of *Deschampsia caespitosa* (marked) is being destroyed by splash erosion. The soil is often carried up particularly by red ants of the genus *Myrmica* but also by the black ants *Lasius niger*. These tussocks are more exposed to the frost than the surrounding ground. When they freeze they are lifted up a little. This means that they later can be easily dried up. If then the vegetation cover is damaged, the soil is rapidly washed away.

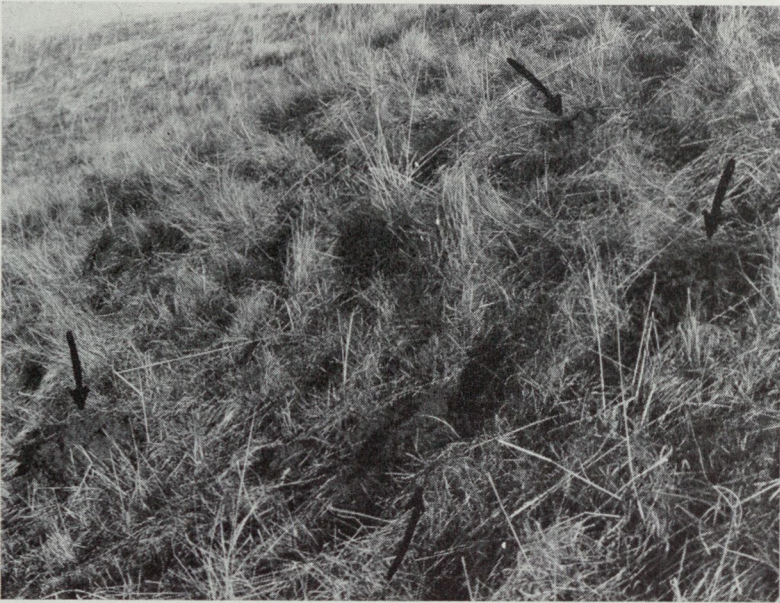
Fig. 20. Water rats have tunnelled in the gully slopes and have thrown up heaps of mould at the mouths to these tunnels (arrows). The nearest heap has been washed and now forms a stripe because of the rain.

slopes. Naturally the tunnels have an undermining effect, as the heaps of excavated soil are washed downslope (Fig. 20).

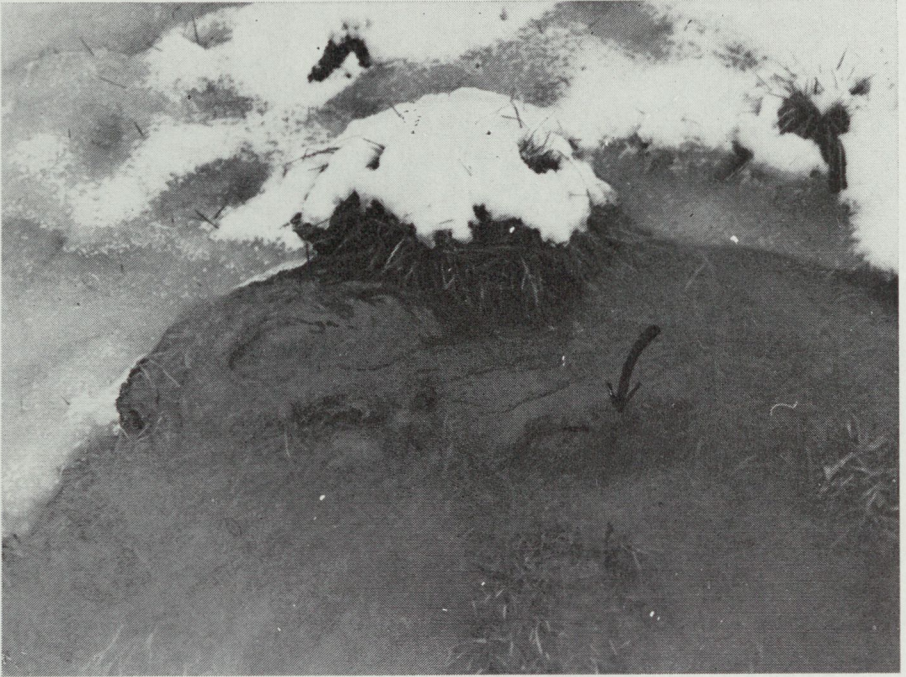
Fig. 21. Close-up of the mouth of the subterranean channel. The artesian water wells up to the left of the tussock. Straws and roots have been twisted together to form a roll in front of the bulge (arrow). The appearance of the bottom changes with the water discharge in the channel and lumps of clay as well as sand and silt can now and then be found on it.
