SVERIGES GEOLOGISKA UNDERSÖKNING

SERIE C NR 772 AVHANDLINGAR OCH UPPSATSER ARSBOK 73 NR 13

ÅKE HILLEFORS

THE LANDSLIDE AT GUNNILSE  
IN THE LÄRJE VALLEY  
WESTERN SWEDEN

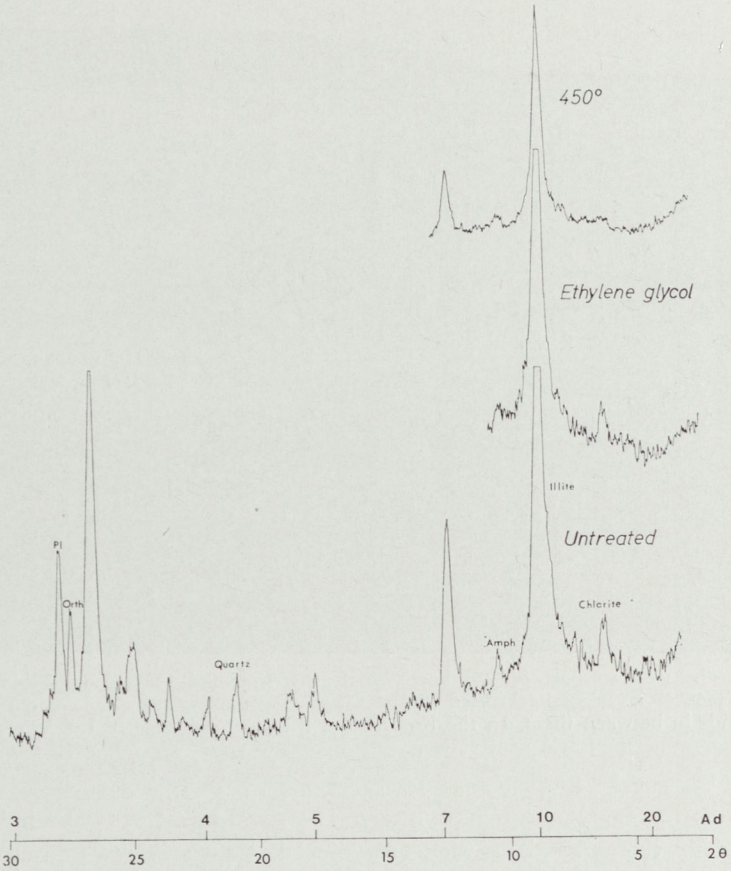
Four samples from different depths of a boring in the Måssen area have now been investigated by X-ray diffractometry — untreated, treated with ethylene and glycol and after heating to 450°C. All the diffractograms reveal a clay predominated by illite and with a small amount of chlorite. No swelling minerals or kaolinite were detected. Non-clay minerals were represented by feldspars, quartz and amphiboles. Only one diffractogram is published here (Fig. 12).

Fig. 12. X-ray diffractograms for oriented sample of marine clay from Gunnilse (12 m depth, the Mässen core). The clay minerals are illite (dominant) and chlorite. Non-clay minerals are quartz, feldspars and amphiboles. Other samples from 3, 6 and 9 m depth show the same composition.
