The geological evolution of Stockholm – bedrock, Quaternary deposits and experience from infrastructure projects

SGU-rapport 2019:18

Project name: Byggnadsgeologisk karta Stockholm

This report complements the updated construction geological map of the Stockholm region (www.sgu.se). The content is based on available internal (SGU) and external geological information. The purpose of the report is to provide a brief description of the bedrock and Quaternary deposits, as well as geological evolution in the Stockholm area. The main report is divided into two sections, the first dealing with bedrock geology and the second with drift-Quaternary deposits. In addition, there are two appendices describing experiences from infrastructure projects in the Stockholm area. Authorship of the different parts is as follows:

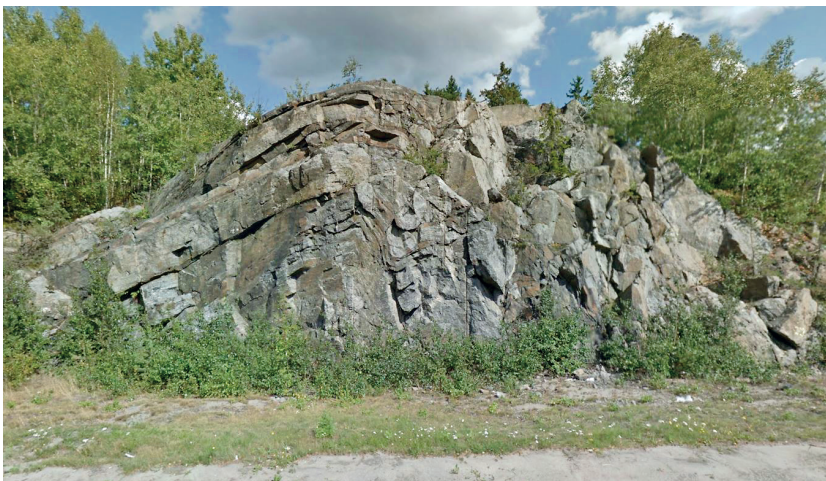
Figure 10. Folding in m-scale in metasedimentary veined gneiss. Nynäsvägen close to Haninge, southern Stockholm. Photo: Google Maps.

out to Värmdölandet. The eastern hinge of the antiform essentially follows the eastern part of Värmdölandet. The Ingarölandet synform covers the Enskede–Johanneshov–Saltsjöbaden area and further east to Ingarö (Fig. 9). The western hinge of the synform is located in the Gröndal area. The transition between the synform and the antiform runs in an east–west direction along Årstaviken–Järlasjön–Lännerstasundet and further eastwards. There are also related minor synforms and antiforms in 1 m–100 m scale, which means that the planar structures may differ locally more or less strongly from the regional structural trend (cf. Figs. 3A and 10).

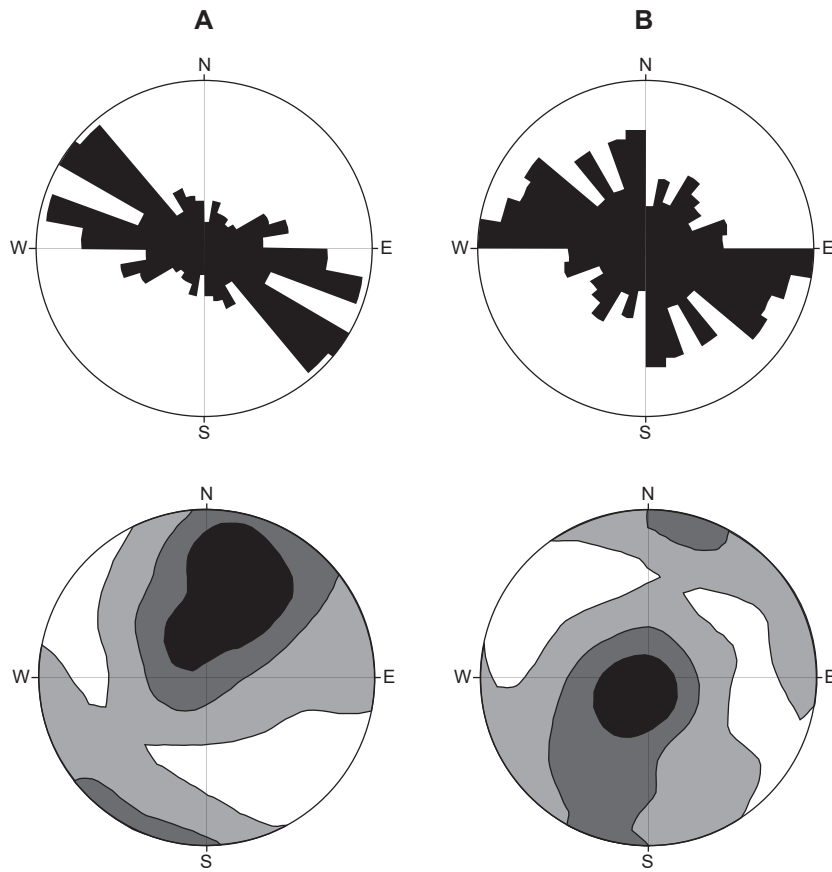
Figure 18. A. Orientation of fractures in borehole 08F351K ($n = 247$). B. Orientation of fractures in borehole 08F352K ($n = 235$). Figures redrawn and simplified after Vass (2012).

Fracture orientations have also been documented in three drill holes: a 421 m long hole orientated northwards (10F353K) from Lovön out into Lambarfjärden towards Hässelbystrand, and two 99 m long moderately inclined holes, in opposing directions, one towards the north-northeast (08F351K) and one towards the south-southwest (08F352K) in Lambarfjärden. The two moderately inclined holes predominantly feature west-northwest to northwest fractures, as well as north-south-orientated fractures in borehole 08F352K (Fig. 18). Moderately to steeply dipping towards the southwest and steeply dipping fractures towards the northeast predominate in the borehole drilled towards the north-northeast (08F351K), while gentle to sub-horizontal dips predominate in the borehole drilled towards the southwest, but steep west-northwest fractures also occur (08F352K). In the long borehole drilled from Lovön (10F353K), gently dipping to sub-horizontal fractures predominate in the upper part between 3 and 207 m borehole length, but steep northwest and northeast fractures also occur (Fig. 19). West-northwest to northwest fractures with moderate dips to the northeast then predominate between 208 and 358 m (Fig. 19). The change in predominance of west-northwest to northwest fractures in the lower part of the borehole may be related to, and influenced by, the fault in Lambarfjärden. For further information from the investigations in Lambarfjärden, see Vass (2012).

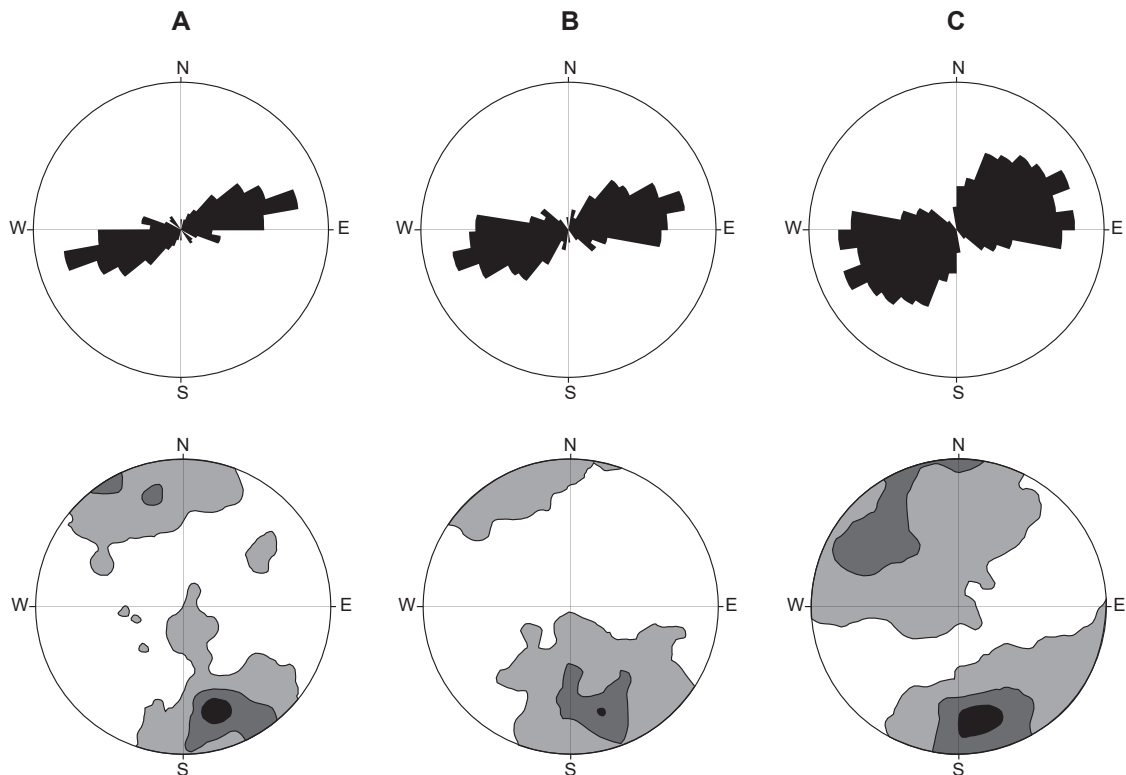
▼ **Figure 21.** Orientation of fractures in the boreholes in Fiskarfjärden. A. 08F152K (n=228). B. 08F153K (n=492). C. 08F156K (n=1784). Figures redrawn and simplified after Ignea (2015).

Northeast fractures with steep northwesterly dips predominate on outcrops in the Sättra area, although subordinate steeply dipping west-northwest fractures also occur (Fig. 20A). At Kungshatt, on the other side of Fiskarfjärden, subvertical east-northeast and northwest-striking fracture sets predominate (Fig. 20B). In the two facing, moderately inclined drill holes, east-northeast fractures with mainly steep to moderate dips towards the north-northwest to northwest predominate, but also dip steeply towards the south-southeast (Figs. 21A and B). In the long borehole that crosses Fiskarfjärden, east-northeast-orientated fractures predominate, with a certain spread between east–west and northeast, with mainly moderate to steep dips, both towards the north-northwest and south-southeast (Fig. 21C).

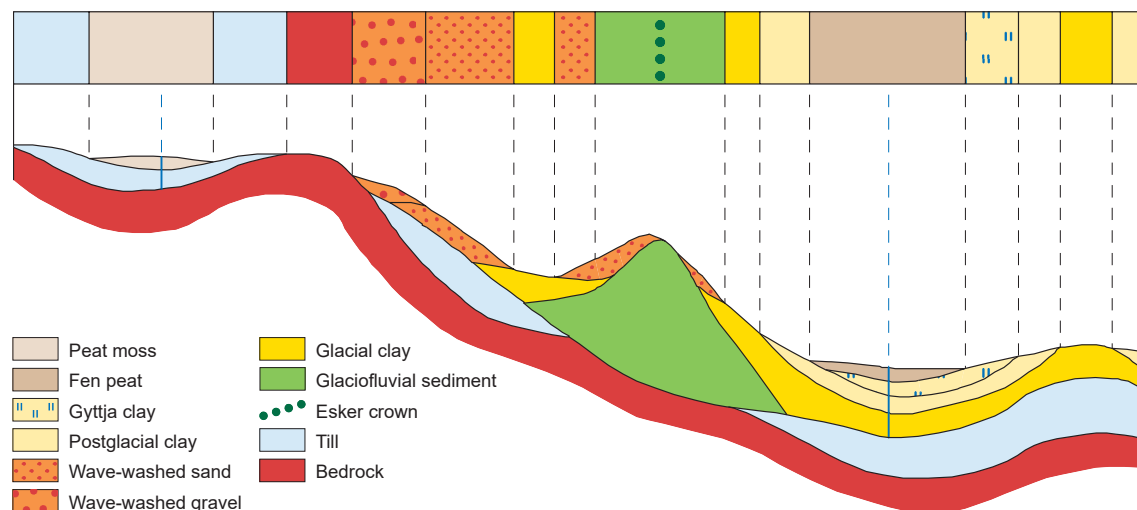
Figure 30. Generalised soil profile showing the distribution of soil types with depth in eastern Sweden.

Since the area as a whole is below the level of the highest coastline, younger soils commonly cover the older deposits. Figure 30 depicts a generalised soil profile, typical of the region, showing the distribution of soil types with depth. The region is primarily characterised by a lack of soil cover in higher areas and thick deposits of fine-grained marine and lake sediments in valleys and at lower elevations (Fig. 31). Till is subordinate, and extensive areas with continuous till cover are rare. North–southerly large eskers are also characteristic of the area, testifying to the large quantities of sediment transported by the rapidly retreating ice sheet.

Till occurs sparsely at the ground surface in the area, but often at depth beneath younger soils (Figs. 30, 31). The till cover is usually not more than a few metres thick. Till deposits of greater thickness can occur on the downstream side of rocky areas in relation to the ice flow direction. Areas with a more continuous till cover are more common north of Lake Mälaren, and till occurs very sparsely at Södertörn (Fig. 31). A clayey and greyish till occurs in the area below the more common sandy-silty till. The former is often referred to as ‘old blue’ and probably represents an earlier stage of the latest deglaciation. ‘Old blue’ is often compact and over-consolidated, and is found mainly on the downstream side of rocky hills, in relation to the main ice flow direction during the last glaciation. In addition to the lee-side moraines with drumlin forms found in the area, there are numerous De Geer moraines (Fig. 32). These are characteristic of Mälardalen and often occur in swarms. The De Geer moraines are lower, 2–5 m high, and more irregular and winding than normal moraine ridges, in most cases no more than a dozen metres wide and essentially orientated parallel to the ice front (Fig. 33). In many cases, De Geer moraines are block-rich, particularly if they occur in farming areas where farmers have added boulders and stones removed from cultivated fields.

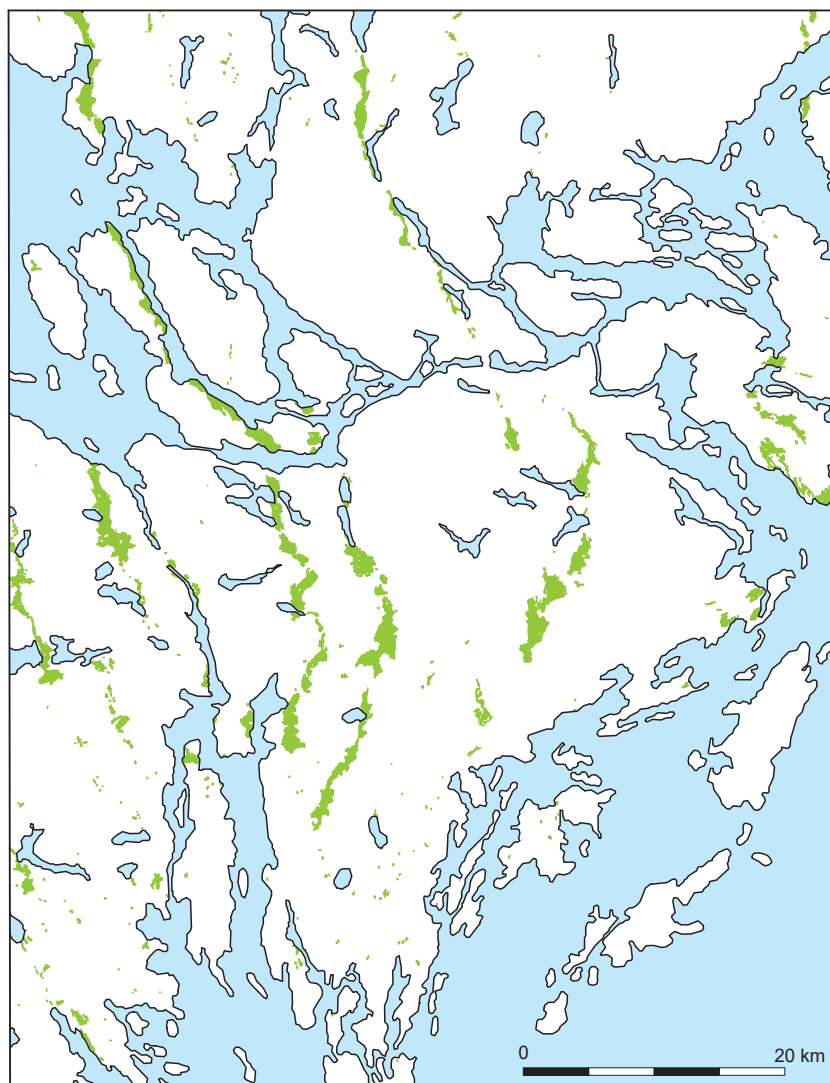
Figure 34. Esker deposits in the Stockholm area.

The lowlands of south-central Sweden are characterised by large eskers, deposited in a subaquatic environment and trending parallel with the direction of the ice retreat. The main eskers in the Stockholm area are shown in Figure 34. Sediment thickness in the ridges can be over 50 m. Their internal structure is often complex and reflects the supply of meltwater and sediment from the ice sheet, as well as the extensive reworking of the ridges as they were raised above sea level. As a rule, there is a core of coarser cobbly gravel material over which more sandy gravelly material is draped (Lundqvist 1979). These glaciofluvial materials have subsequently been affected by beach and stream processes. The reworked sediments that often cover the sides of the ridges are underlain by clay covering the sides of the ridge. Where the eskers are less well developed, they may be completely covered by clay, and the landform may not be visible at all. In the Stockholm area in particular, there are the '*malmarna*', which are large, well-developed delta-like formations. Pålarmalm at Södertörn is the last remaining example where their character and morphology can be observed. *Malmarna* are highly complex and represent a period when the ice retreat began to increase as the climate warmed during the transition from the Pleistocene (Younger Dryas) to the Holocene (Lundqvist & Vilborg 1998). Sediment supply increased but the ice front did not retreat so quickly northwards, which caused material to accumulate in large delta-like deposits. South of *malmarna*, the deposits are much smaller. In the north of the Stockholm area, where the ice retreated much more quickly (Fig. 29), certain eskers vary in how they were formed; broader parts appear as hills, with smaller narrower sections between them. These are known as "esker trains" (Lundqvist 1999). This may reflect some cyclicity in the supply of meltwater and sediments due to climatic variations (Lundqvist 1999).

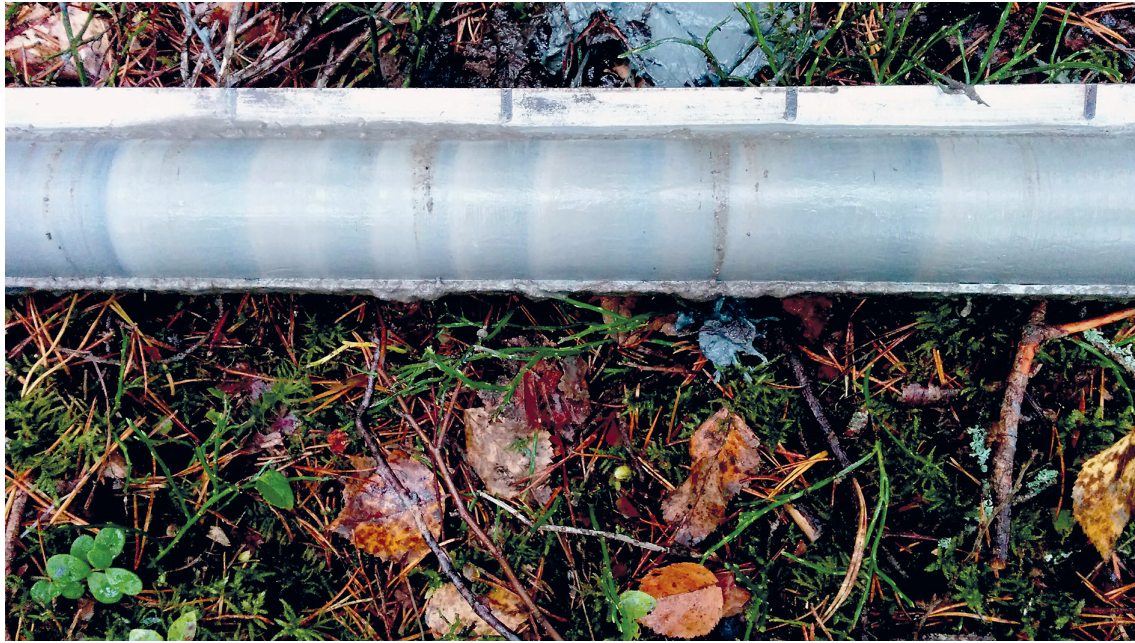
Figure 35. Diffusely varved clay deposited during the Yoldia Sea brackish-marine phase. The light layers were deposited at the beginning of the year, transitioning into brownish layers during summer and autumn. The end of the annual varve is marked by a darker brown to black layer, representing winter sedimentation. Photo: Stefan Wastegård.

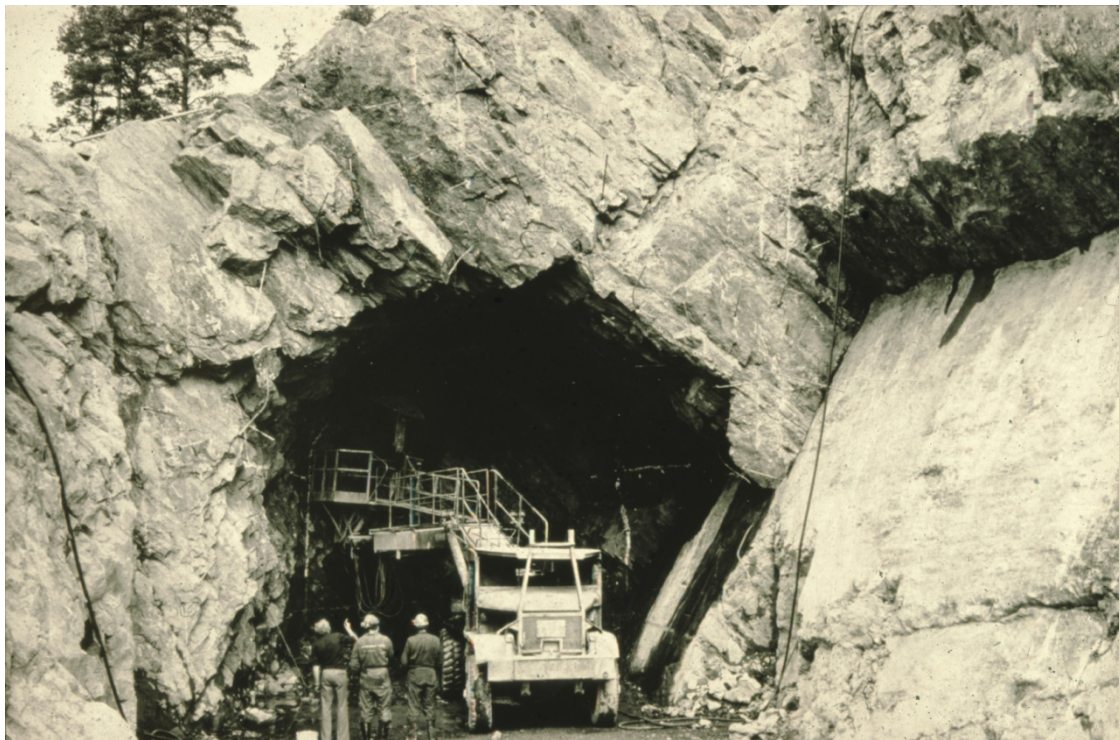
Moderately dipping fractures at the tunnel portal for a de-icing facility in Älvsjö.

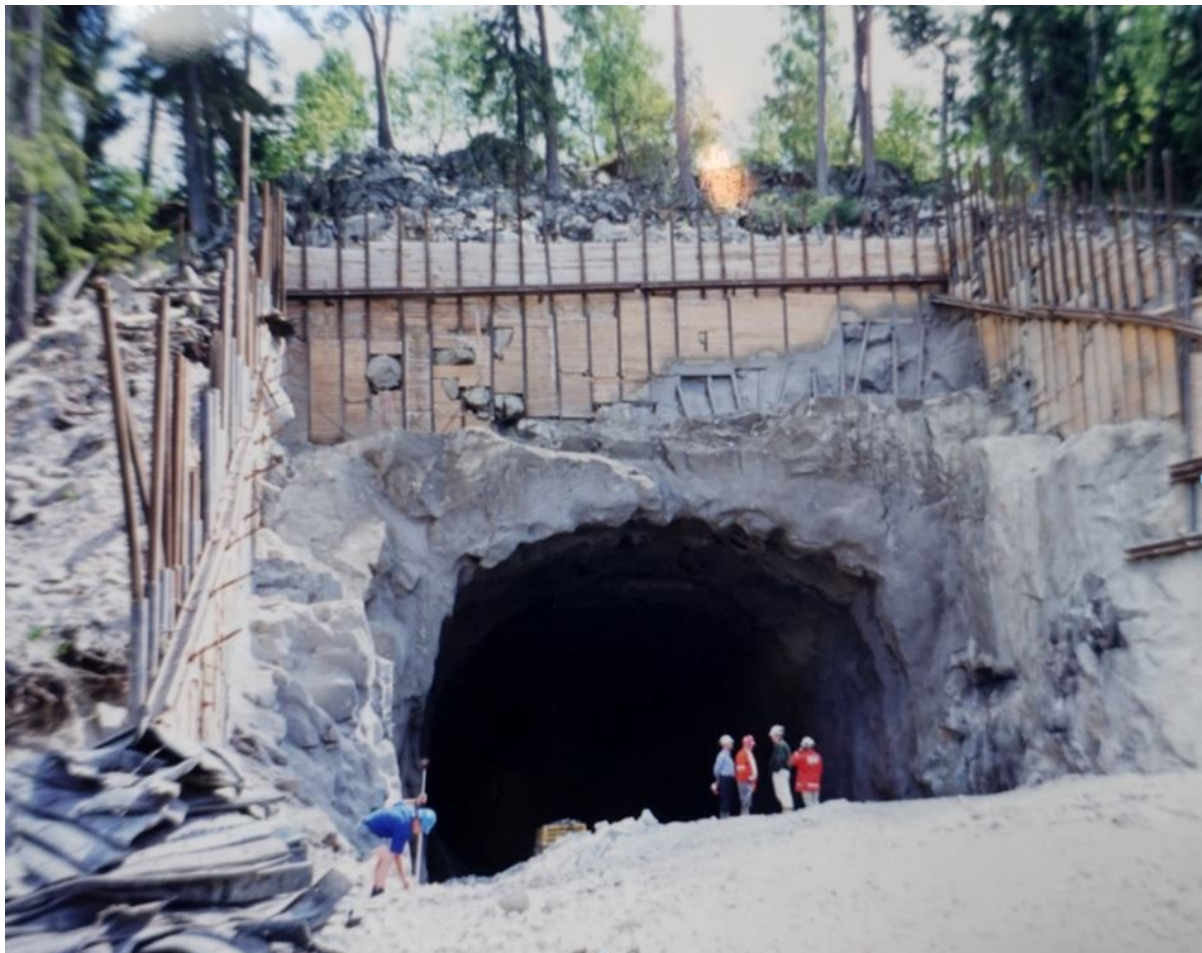
Figure 1. Railway tunnel south of Kungsängen. Blocky till on top of an irregular bedrock surface.

Some examples of geological conditions that have had negative consequences should be mentioned. For example, the double track train tunnel, south of Kungsängen on the Kallhäll-Kungsängen line, where the presence of very blocky terrain complicated drilling and precluded seismic surveys (fig.1). The project consultant suggested a deeper tunnel, while the client decided upon a shallower depth to achieve a better track geometry. The actual bedrock surface proved to be very irregular during the construction phase and resulted in the costly necessity of part of the tunnel being cast wholly in concrete after extensive excavation from the ground surface.

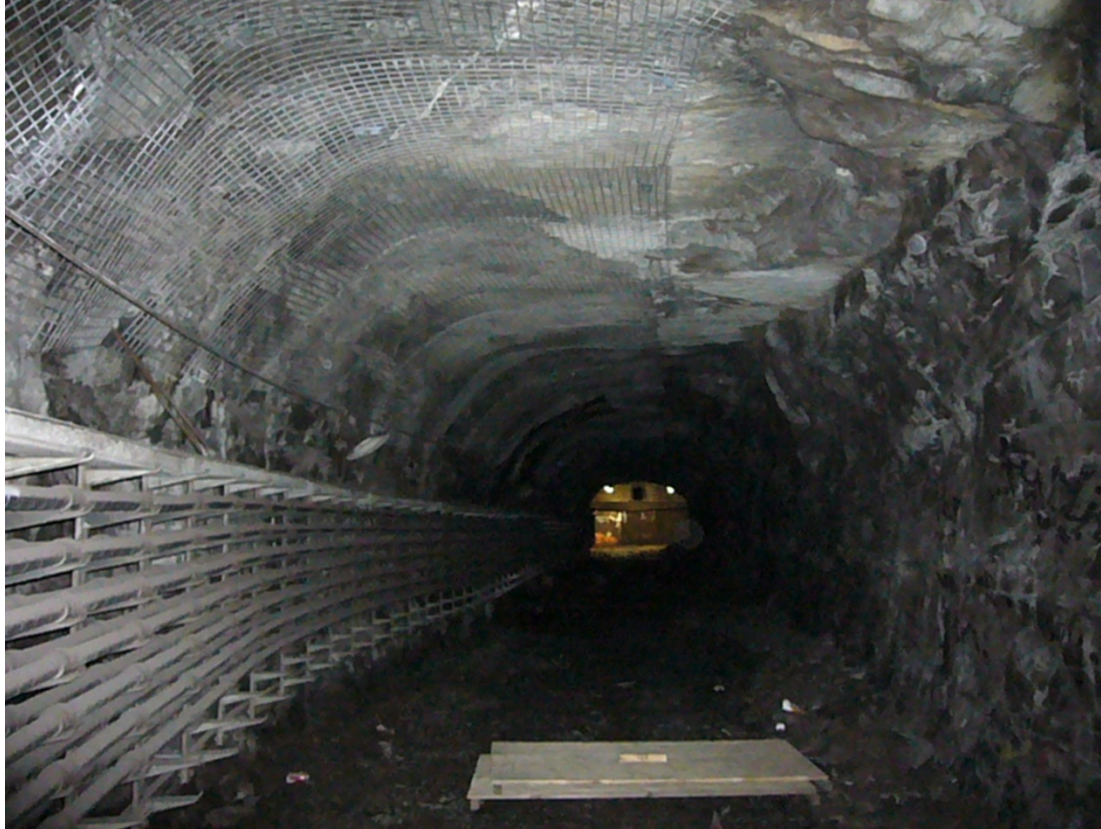
Figure 2. Ventilation tunnel at Hälsingehöjden. Failing of thin rock slabs and even evidence of rock bursts behind a reinforcement grid in the roof.

Near Hälsingehöjden, Vasastaden, in a shallow lying ventilation tunnel to the metro, 'peeling' of thin rock slabs was noted and also clear block fall out behind a reinforcement net in the roof (fig.2). The rock consists of relatively fine-grained granite.

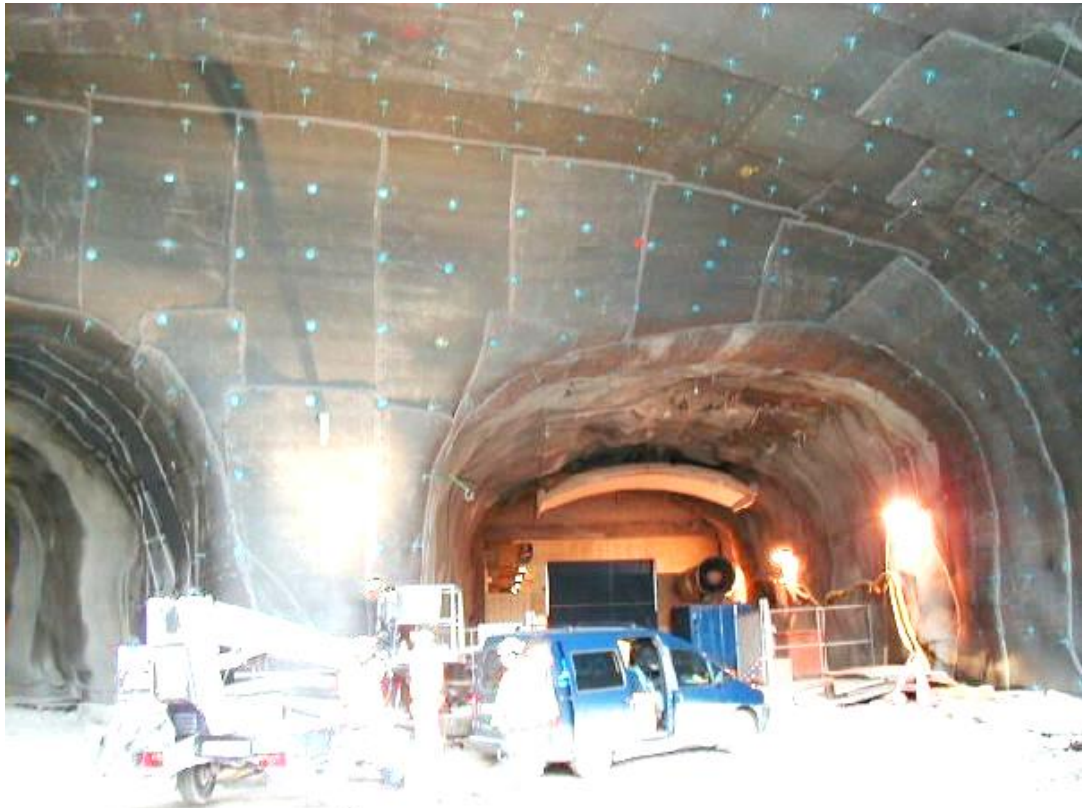
Figure 3. The so-called Örsta vault in the Södra länken tunnel.

The deformation measurements were difficult to interpret, but it has been estimated that the rock at the portal has sunk by 5-6 mm while the rock moved outwards by 15-17 mm. The rock above the tunnel fractured in connection with the excavation work and has been grouted several times due to water leakage. Fracturing has been observed in the overlying outcrops and in the shotcrete in the tunnel roof. The final construction solution for leakage and ice control was that the roof and walls were completely covered with an insulating material in to the pillar nose, about 20 m in from the portal (fig. 3).

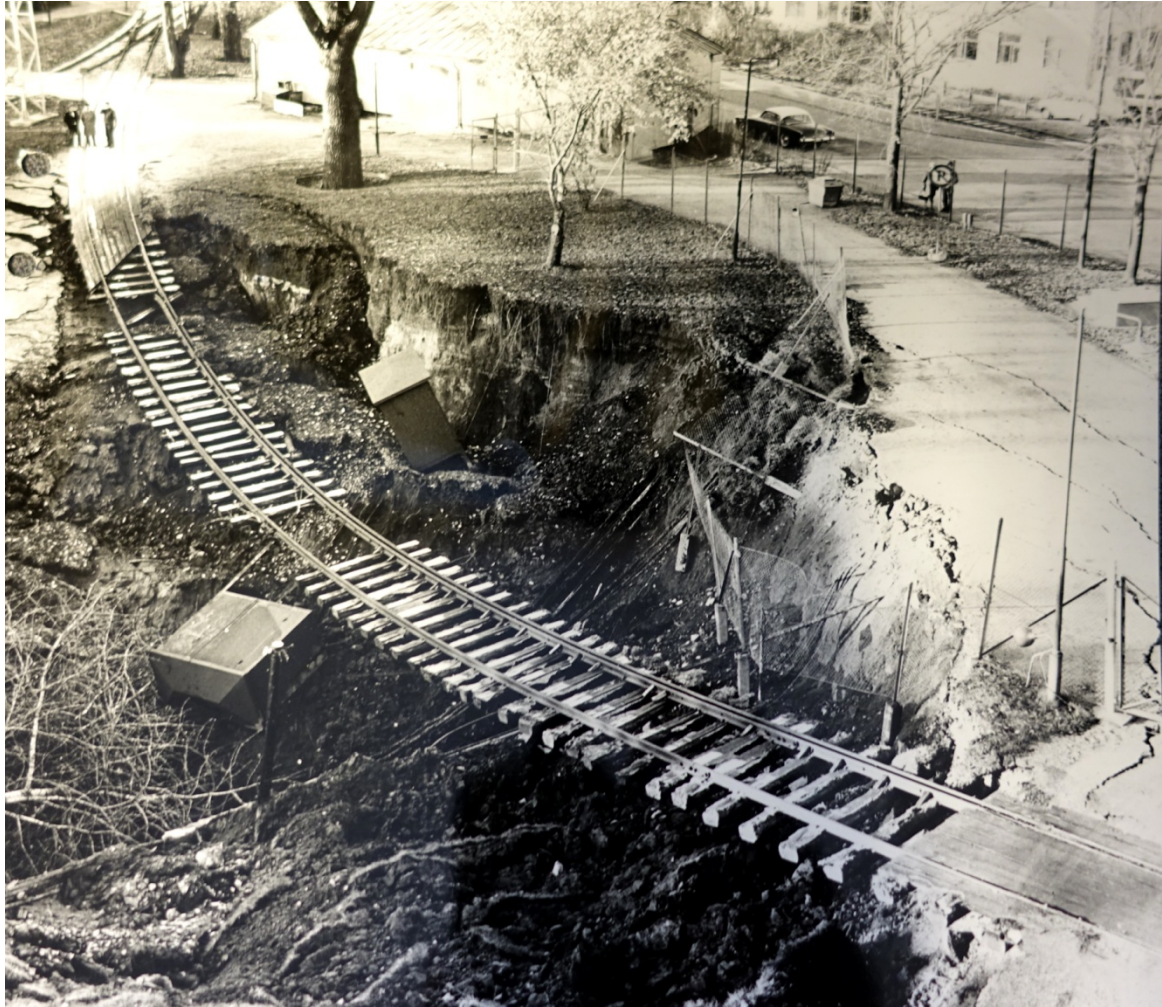
Figure 4. The tunnel collapse that occurred in 1965 at Mårtensdal, Södra Hammarbyhamnen.

One of the most discussed failures occurred in November 1965 when excavating a tunnel perpendicular to and under Södra Hammarbyhamnen near Skanstull. There was a tunnel collapse and two workers were trapped, but managed to reach an air pocket at the tunnel front at Ringvägen. There was a lot of publicity and a special drilling machine from Germany was brought in. They drilled down into the tunnel and managed to supply food and set up telephone contact with the trapped workers. They were later rescued by excavating from an associated shaft on Södermalm. It was first assumed that soil and water from Södra Hammarbyhamnen had penetrated the tunnel, but it turned out that the failure occurred in the tunnel's second excavation front on the other side of Södra Hammarbyhamnen at Mårtensdal. An extensive crater formed at the surface where large transformers and minor buildings had toppled over (fig.4). The evening before the collapse, the tunnel had little or no bedrock cover and penetrated a soil mass at about -22 m. After extensive excavation at the collapse point from the Södermalm site, a concrete plug was cast in the tunnel about 160 m away from the point of collapse, and a new tunnel was driven, following a steep down gradient to a level 10 m below the initially planned level, where the tunnel continued below and to the side of the collapse site.

From Södra Hammarbyhamnen and southwards, soil and rock probing was carried out as far as southern Hammarbyvägen. Then a stretch of about 400 m had been assumed to have sufficient rock cover and it was after about 250 m that the collapse occurred in a deep depression in the bedrock. The depression was oriented east-west and was judged to have been encountered in the foundation of the southern part of Johanneshov's bridge, where bedrock was found 15-20 m below the water surface and piles were drilled 5-6 m down into poorer quality rock, before sufficient bearing capacity was obtained.

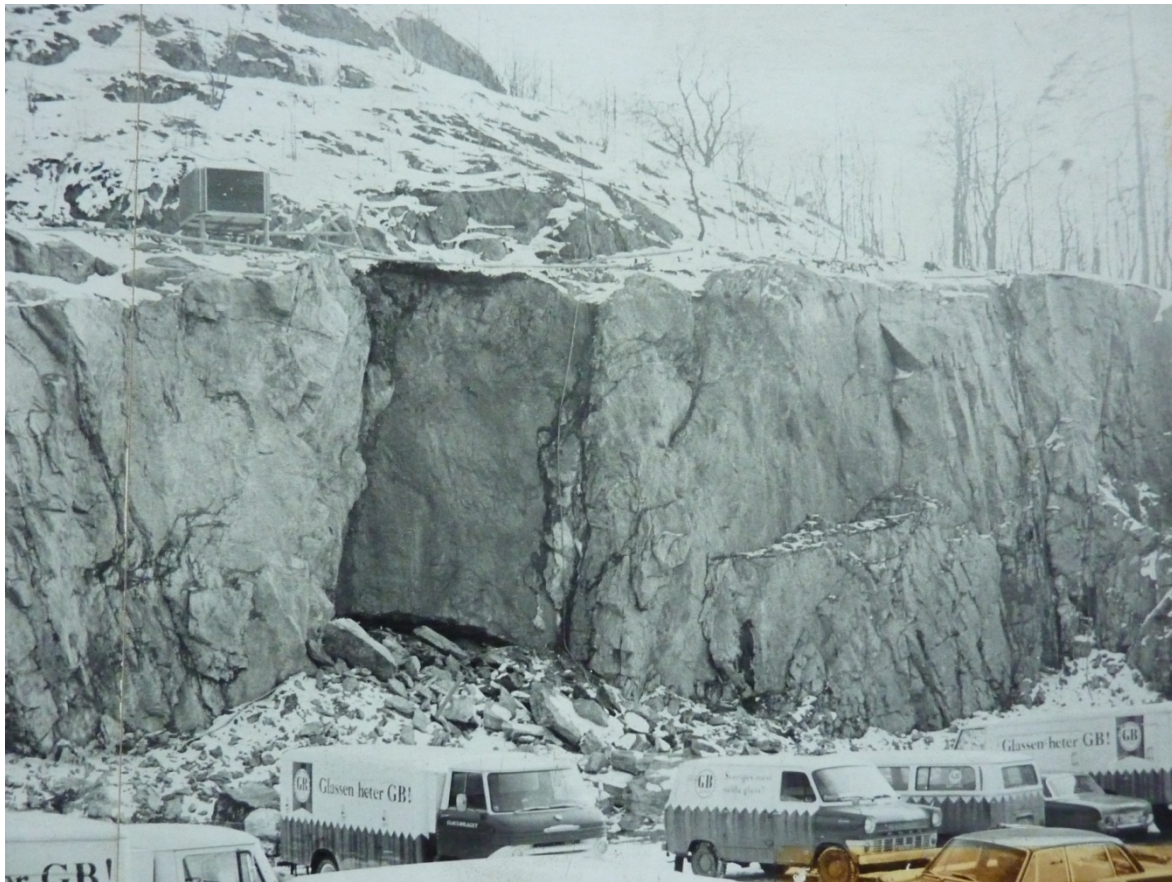
Figure 5. The rock slope failure at Glace Bolaget AB in Årstadal 1972.

In Årstadal, near Liljeholmen, a failure occurred in 1972 when excavating rock to improve access to existing rock caverns (fig.5). An approximately 2 m thick and 6 m wide vertical slab of rock detached from the rock slope and slid down in front of the tunnel portal completely blocking it.

Before the failure, distribution vehicles drove frequently in and out of the tunnel through the portal. The reason for the failure was partly the presence of a vertical fracture coated with graphite and partly that the horizontal pressure in the rock had been removed by the new rock excavation.

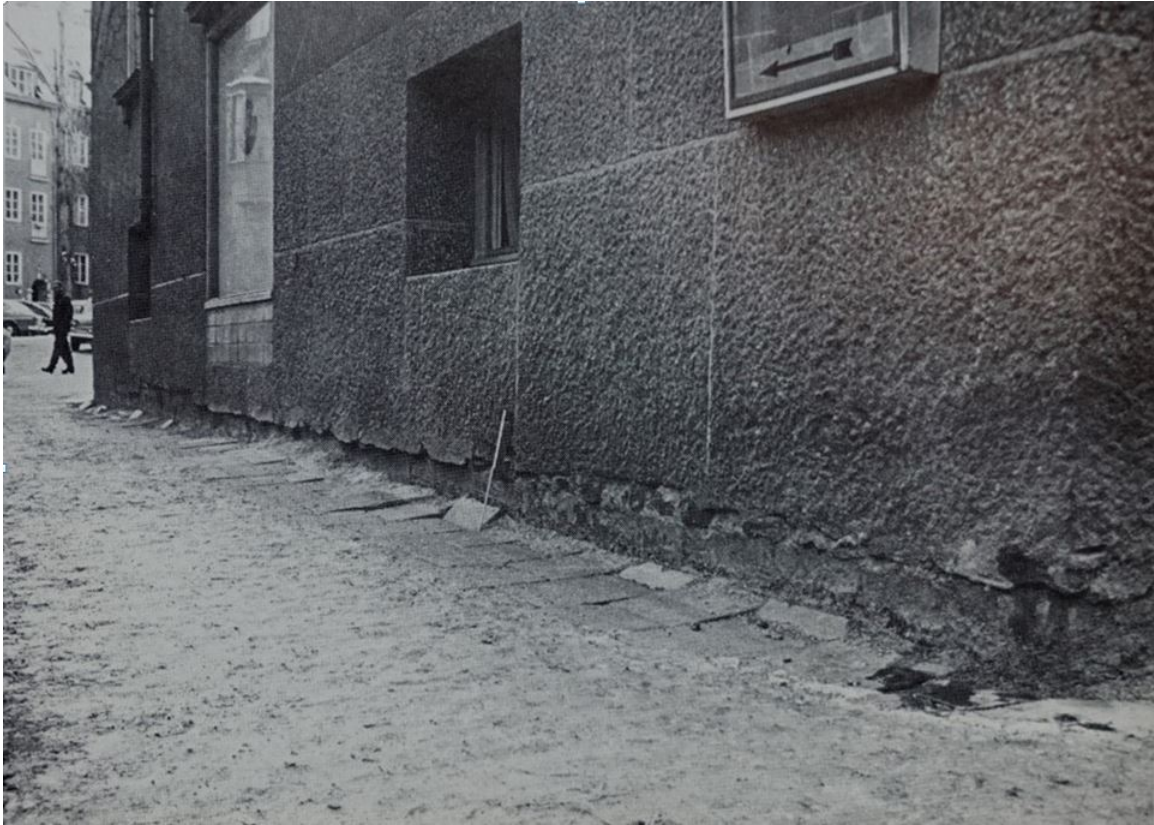
Figure 6. Karlaplan area 1964. Subsidence of the street adjacent to a building supported on wooden piles.

When two different tunnels, with different owners, were being excavated at Karlaplan, a 6 m fall in the groundwater level occurred within approximately one week. Water stopped leaking into the tunnels but ground settlements were rapidly developing. The sidewalks were disrupted and boilers hung from their pipes in cellars. The tunnels were sealed and artificial infiltration was started. However, there were lengthy legal negotiations and extensive restoration work was required (fig.6 and 7, from Byggnadsgeologi, Staden och grundvattnet).

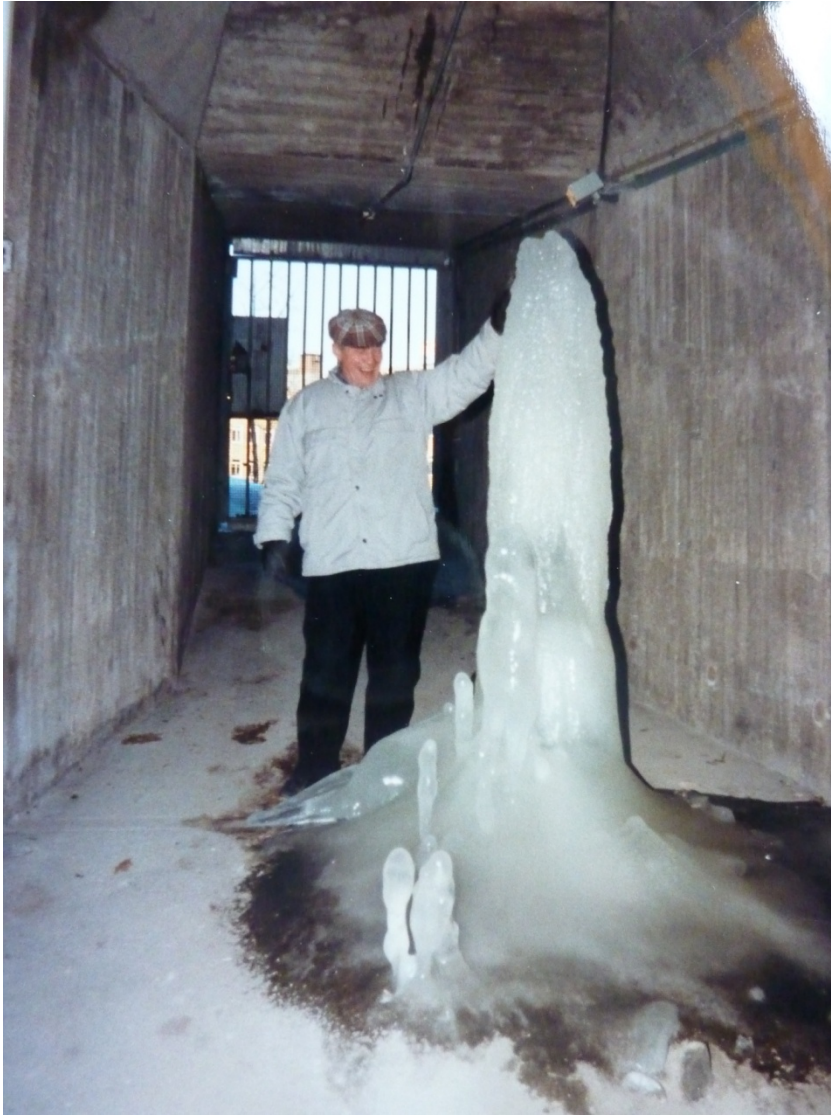
Figure 8. Ice build up in a tunnel.

Problems with ice occur anywhere where water exits the rock during the winter period (fig.8). An old misconception is that ice build up ceases when the ice has sealed the leak, which it does not. Depending on the location of ice formation, it implies greater or lesser risks and associated

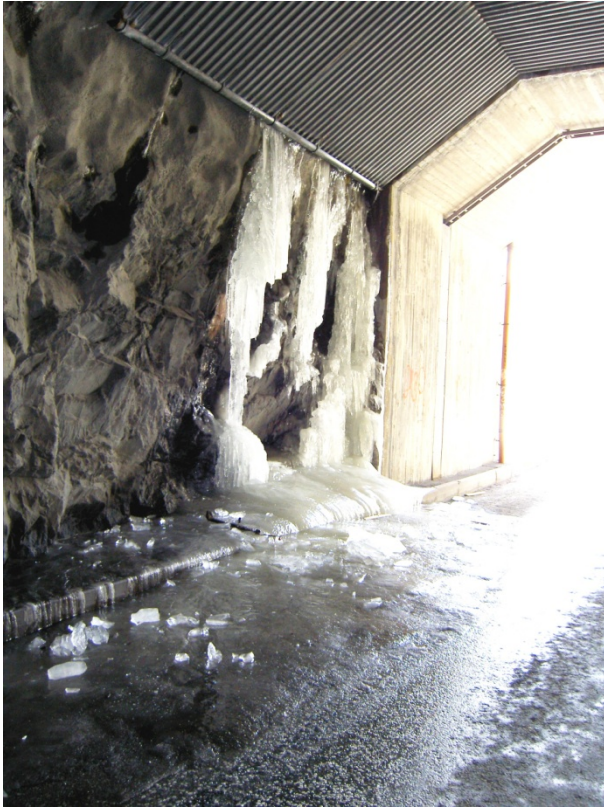
Figure 9. Ice formation in the Finnberg tunnel before remedial measures.

In the Finnberg tunnel there was major ice formation especially at the upper tunnel portal (fig.9). To solve the ice problems, flexible insulating sheets of extruded polyethylene were mounted in the roof and walls at the portal and for a distance into the tunnel (fig.10).

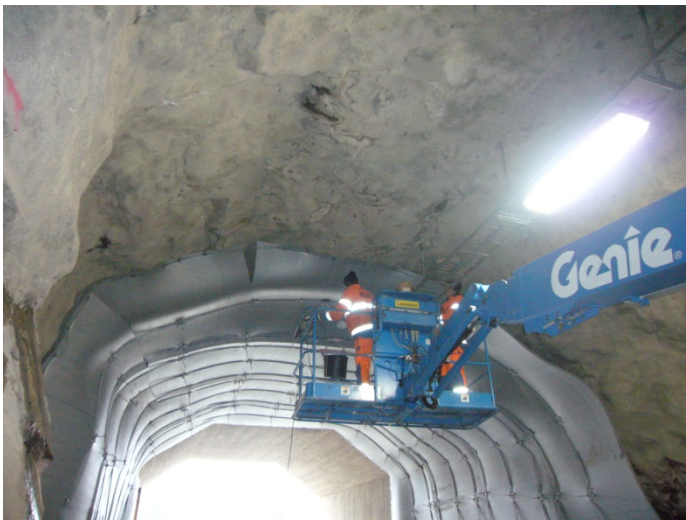
Figure 10. Sheets of extruded polyethylene being installed in the roof and walls at the portal and for a distance into the Finnberg tunnel.

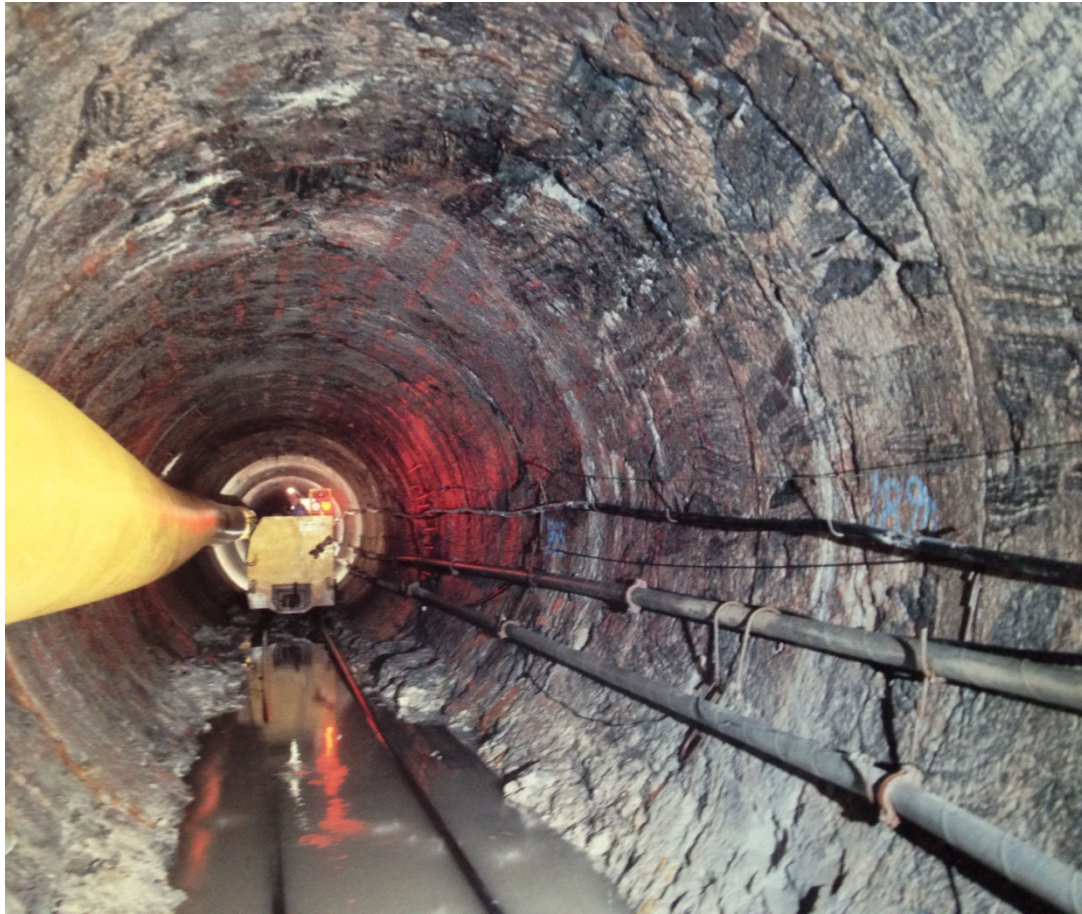
Figure 11. The Saltsjö tunnel

In the case of the Ormen tunnel, the machine had been modified so that pre-excavation grouting of the rock could also be carried out at the tunnel floor. Both the Saltsjö (fig.11) and Ormen tunnels have a diameter of 3.5 m and a length of 7 km and 4 km, respectively. The tunnels have been drilled under Stockholm at levels between about -20 and -50 m. The Saltsjö tunnel is filled

with water at atmospheric pressure, while the Ormen tunnel is for short-term wastewater storage and is therefore relatively empty for long periods. TBM excavation was tested with a few shorter tunnels in the 1970's in Stockholm, but with too weak machines for the hard rock. In the Saltsjö tunnel, no major weakness zones in the bedrock were intercepted, while the Ormen tunnel penetrated deformation zones under Humlegården, a part of the fault under Birger Jarlsgatan. The rock reinforcement requirements in the tunnels were extremely small and the pre-grouting was not very extensive. One problem with the Saltsjö tunnel was steering the machine, which caused unplanned lateral deviations of 25-30 m and sometimes vertical deviations of 1-2 m. The noise level was low compared to blasting, but still meant that the machine was stopped a few minutes before a performance at the Operan when the machine was 45m below the theatre.

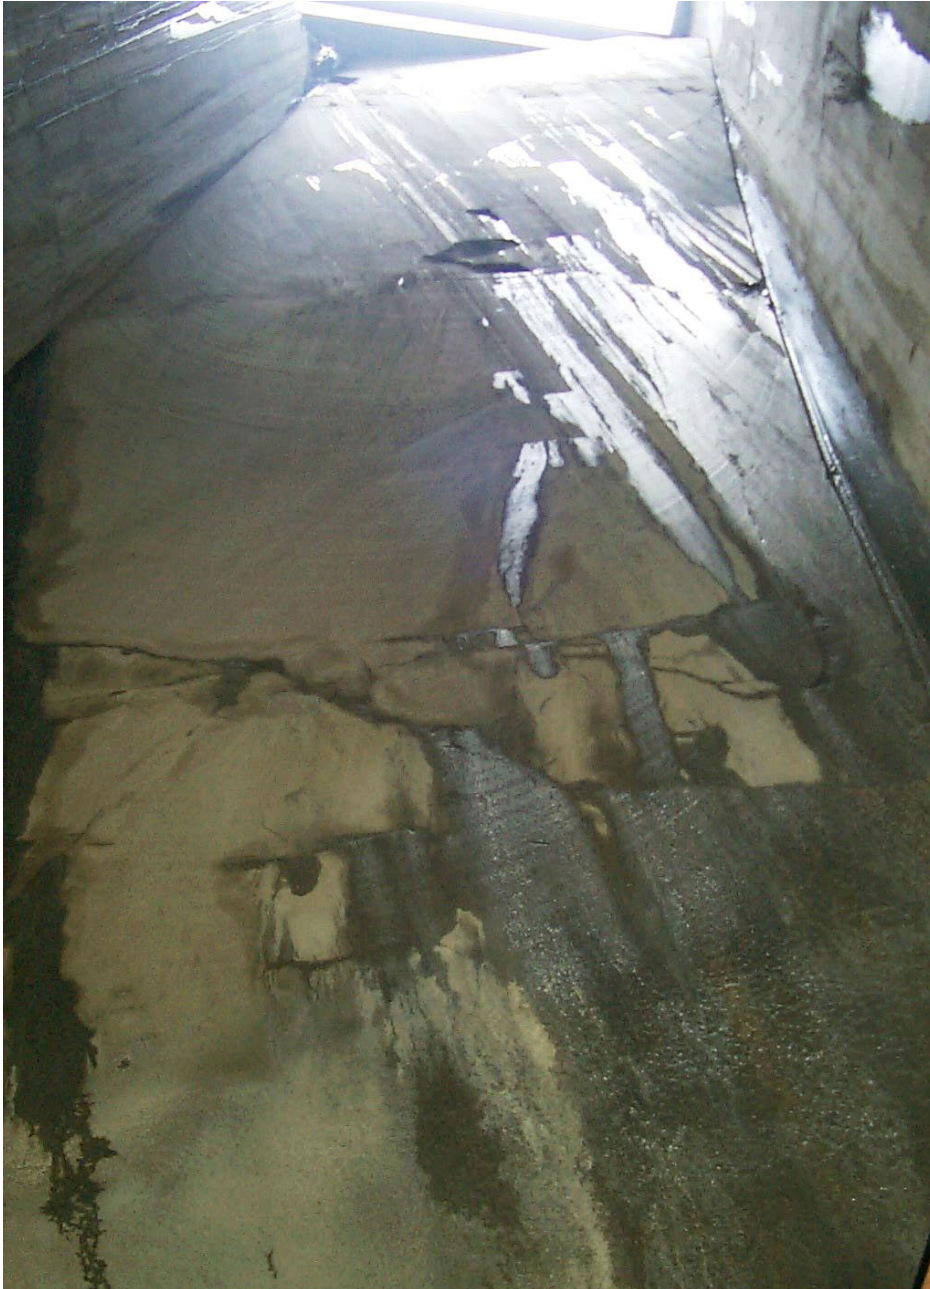
Figure 12. Wire sawing is used more often to prevent vibrations propagating and adversely affecting existing buildings.

In the past, slit drilling was sometimes used along the outermost contour of an open excavation in rock in order to reduce vibrations affecting the neighbouring property. It required that the slit be made completely open to reduce vibrations, but often there was water or stones in the slot which made the difficult and expensive drilling work more or less worthless. Recently, wire sawing of rock as an excavation method has been used more and more with good results and generates minimal disturbance (fig.12). The method is used for all possible applications such as shafts, walls, etc.

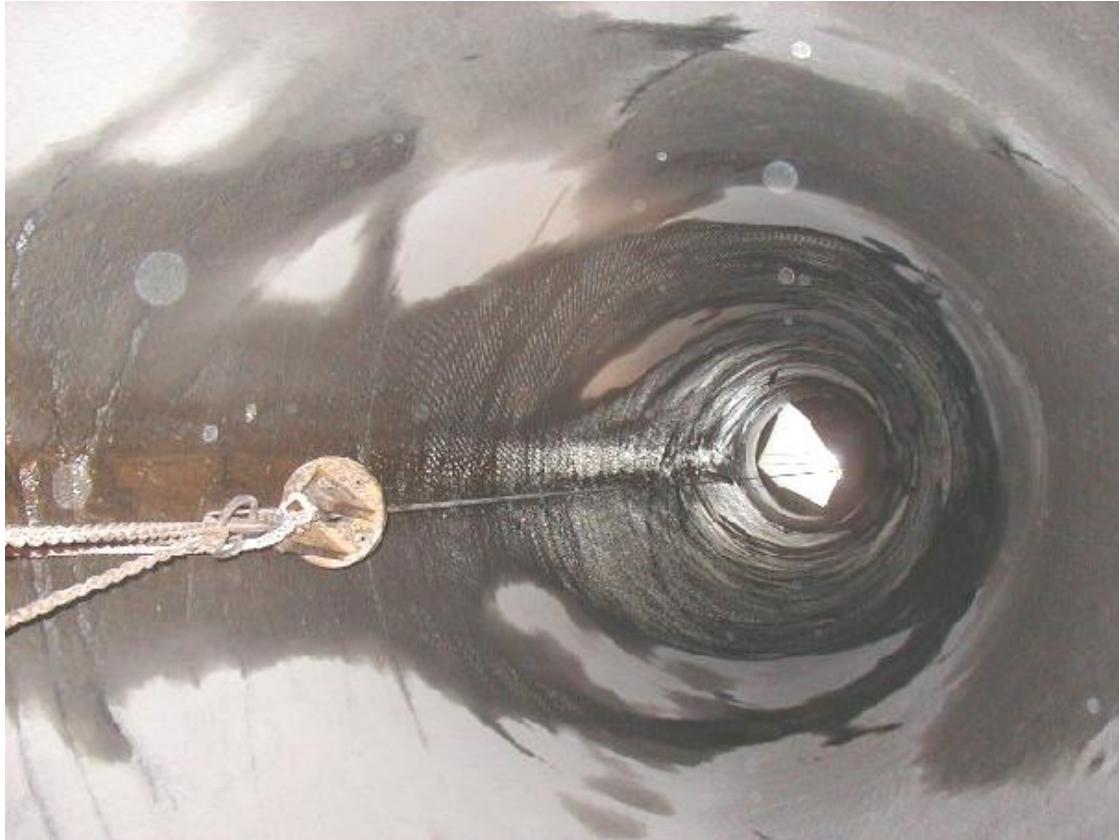
Figure 13. Raise-bored ventilation shaft.

Raise-boring as an excavation technique is used quite frequently for ventilation and other vertical shafts. The method involves a borehole (pilot hole) being drilled down to an underlying space, for example a tunnel, thereafter a much larger borehole crown (a reamer-head suitable for the required shaft diameter) is placed on the drill rod, after which the drilling direction is reversed being raised back towards the machine, with the waste rock falling downwards (fig.13). It is important to consider the need for any pre grouting before excavation and be aware that installation of rock support in a raised bore with poor rock conditions can be problematic.

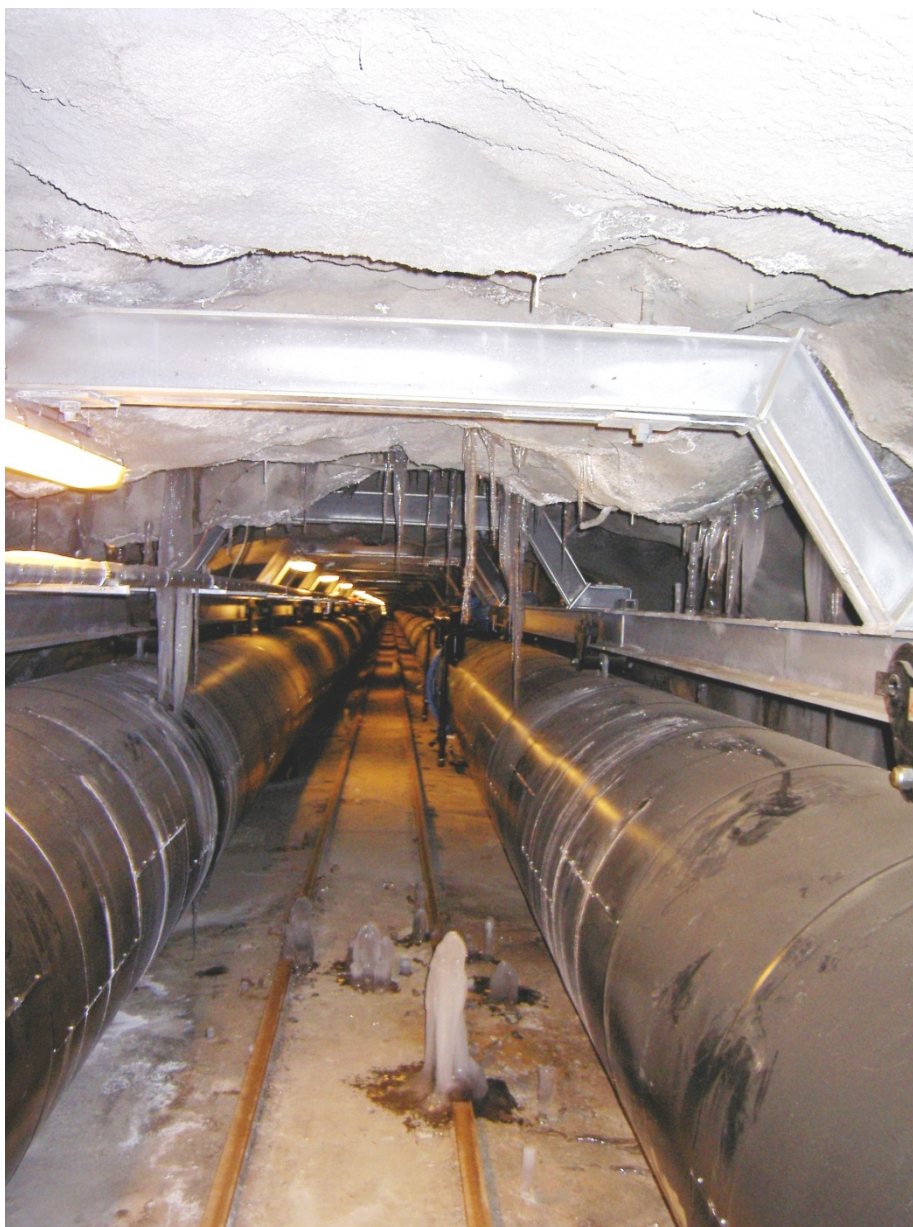
Figure 14. Heavy pipes suspended from the tunnel roof. Load testing was necessary to ensure the capacity of the rock anchors.

The significance of the correct design and performance is shown by a contract for hanging heavy pipes from the tunnel roof with bolts in the rock. The contractor claimed that testing of the bolts was unnecessary, since they were installed correctly. Test loading was ordered with regard to what would happen if the pipes fell down during operation. A number of bolts failed and had to be re-installed - they were then approved after a new test run (fig.14).
