The geological evolution of Stockholm – bedrock, Quaternary deposits and experience from infrastructure projects

SGU-rapport 2019:18

Project name: Byggnadsgeologisk karta Stockholm

This report complements the updated construction geological map of the Stockholm region (www.sgu.se). The content is based on available internal (SGU) and external geological information. The purpose of the report is to provide a brief description of the bedrock and Quaternary deposits, as well as geological evolution in the Stockholm area. The main report is divided into two sections, the first dealing with bedrock geology and the second with drift-Quaternary deposits. In addition, there are two appendices describing experiences from infrastructure projects in the Stockholm area. Authorship of the different parts is as follows:

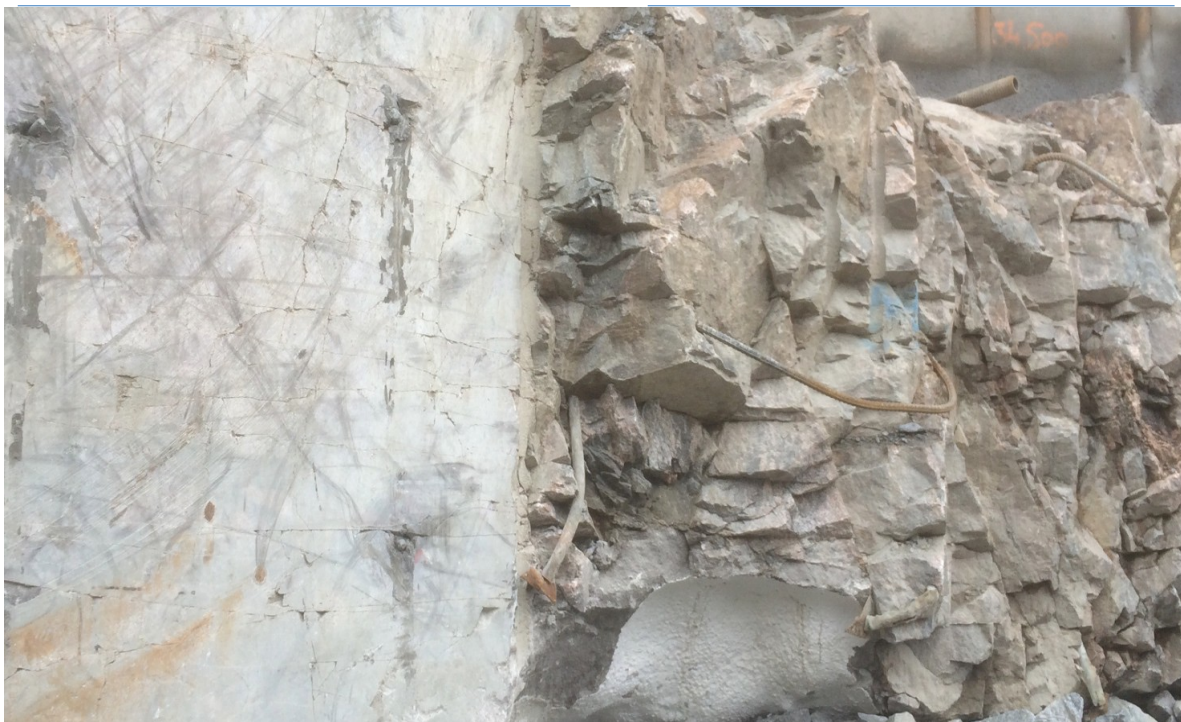
Comparison of a wire-sawn and blasted rock mass.
Photo: Jörgen Theander, Golder Ass.

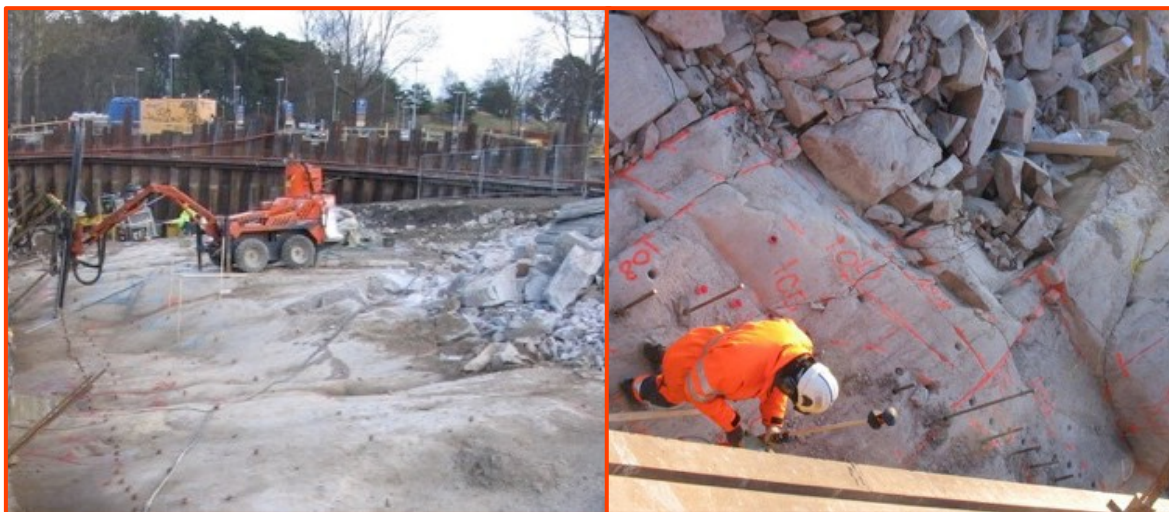
Figure 1. Täby. Left: drilling of contour holes next to a sheet pile wall. Right: in the upper half of the photo, bedrock unintentionally shattered by blasting gases from a round 4m away can be seen. Photo: Lars M Hansen, Golder.

In areas north of Stockholm, e.g. Täby and Ulvsunda, there are stress relief fractures filled with some centimetres of sand or clay. In connection with blasting in Täby, unforeseen damage occurred to the Vallentuna granite when explosive gases penetrated a planar stress relief joint located above the groundwater surface, lifting a metre thick sheet of surface rock. In this way the rock was completely broken up (Figure 1), which meant that several blasting holes had to be re-drilled.

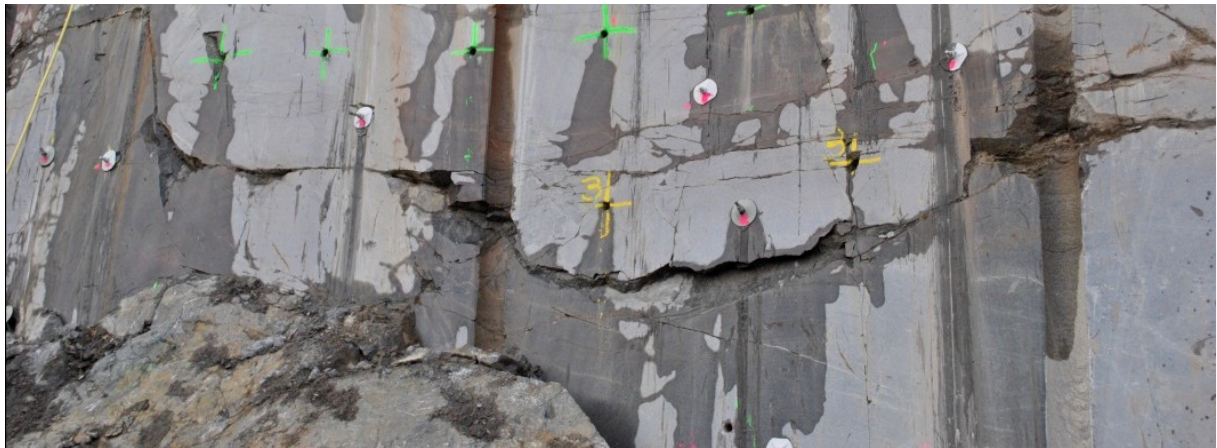
Figure 2. Ulvsunda. Sedimentary gneiss with irregular stress relief joints at 10 m depth below the rock surface, filled with some cm of sediment. Photo: Lars Bergkvist, Golder.

Stress relief joints with a much more irregular shape and clay infillings (Figure 2) were also found in sedimentary gneiss in Ulvsunda, as well as in gneiss at Liljeholmen, where the flat-lying fractures have an irregular shape and even partially follow the steep gneissic foliation (Figure 3). On the other hand, in a sedimentary gneiss at Smista Allé there are persistent stress relief fractures that crosscut the most dominant foliation without being significantly affected by it (Figure 6).

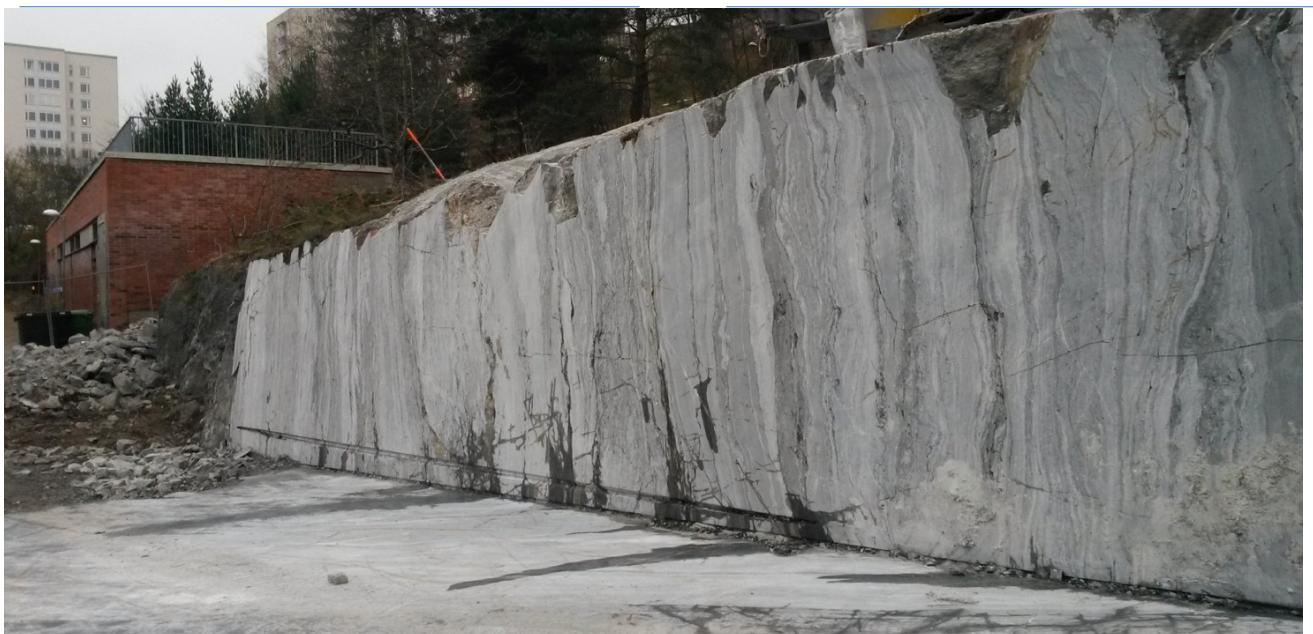
Figure 3. Liljeholmen. Wire sawn rock cut with irregular stress relief joints and steeply dipping gneissic banding/foliation. The rock cut lies above an existing tunnel; both horizontal and vertical wire sawing has been performed to comply with vibration restrictions due to a nearby elevator shaft. Photo: Anja Olsson, Golder.

A funicular railway runs in a tunnel from Liljeholmen underground station. Above the tunnel a new road and houses are being constructed. In order that specified vibration limits should not be exceeded and to avoid damage to electrical equipment in the existing elevator shaft, the road cut was wire sawn instead of blasted (Figure 3). The rock, which is micaceous gneiss, is prone to split along the steep foliation of the mica-rich planes.

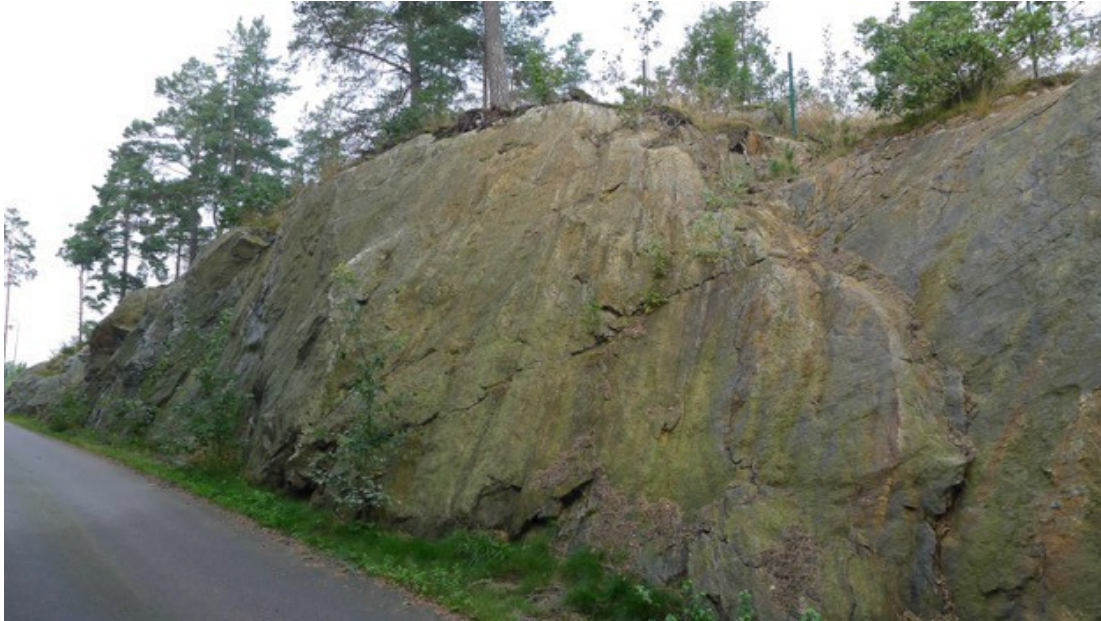
Figure 6. Rock cutting at Smista Allé. The rock cutting is about 3 m high. Due to sliding along a foliation surface, the slope of the face has become flatter than the drilled contour design, which was vertical. The limited face height resulted in a manageable outcome, and the slope is now stable as it now is compatible with the existing rock structure. Photo: Lars Bergkvist, Golder.

In the above examples (Figure 6 and Figure 7), existing facilities are not affected. Figures 9, 10 and 11, on the other hand, show power line supports that are founded on rock near a road that is to be widened. One of these supports stands on rock of poorer quality (Figure 9), another in an area with planar structures that have an unfavourable orientation and undesirable position.

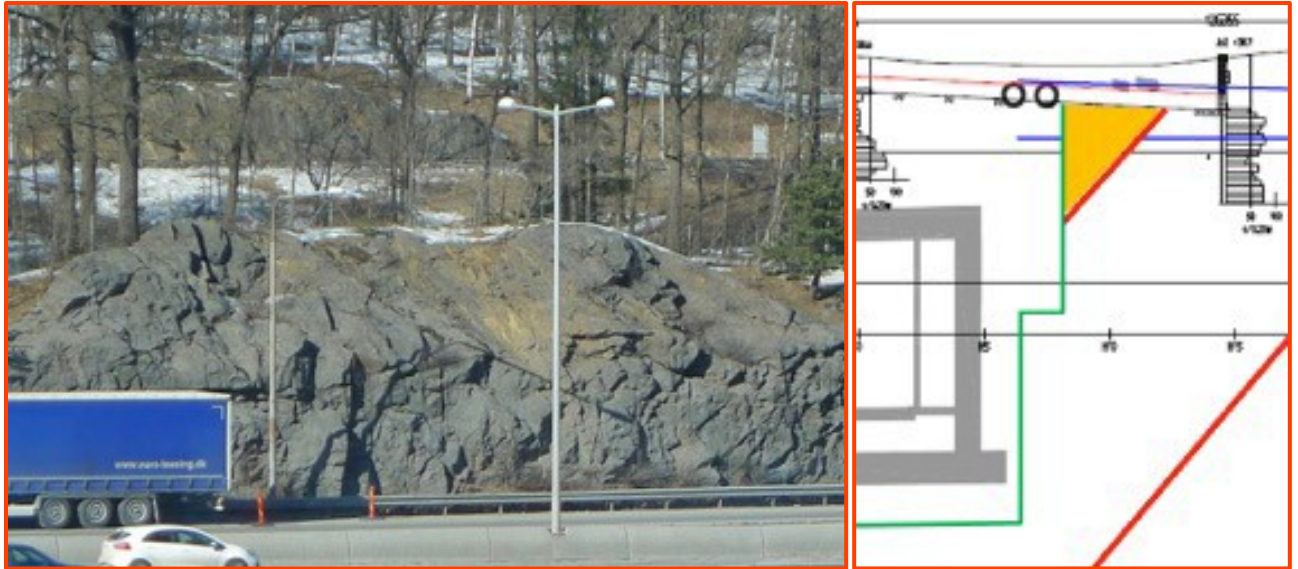
Figure 8. Rock cutting at E4 / E20 at Kungens Kurva. The rock cutting is about 6 m high. The contour holes have been drilled vertically, but due to rock slides, the upper slope profile has become flatter. The exposure of the failure plane high on the slope limited the slide volume. The lower red line, in the right figure, indicates a structure that is far enough from the shaft to form support for the rock mass. Photo: Lars M Hansen.

Figure 35. Excavation with drilled pile wall consisting of casing and welded plate, where the rock wall to the left has been cut with a wire saw and blasted to the right. Below the foot (dark area to the right of the middle, where the lower end of the feed tube hangs) blocks have slipped out, a slip of the same type as shown in Figure 8. Photo Mikael Creütz, Golder.

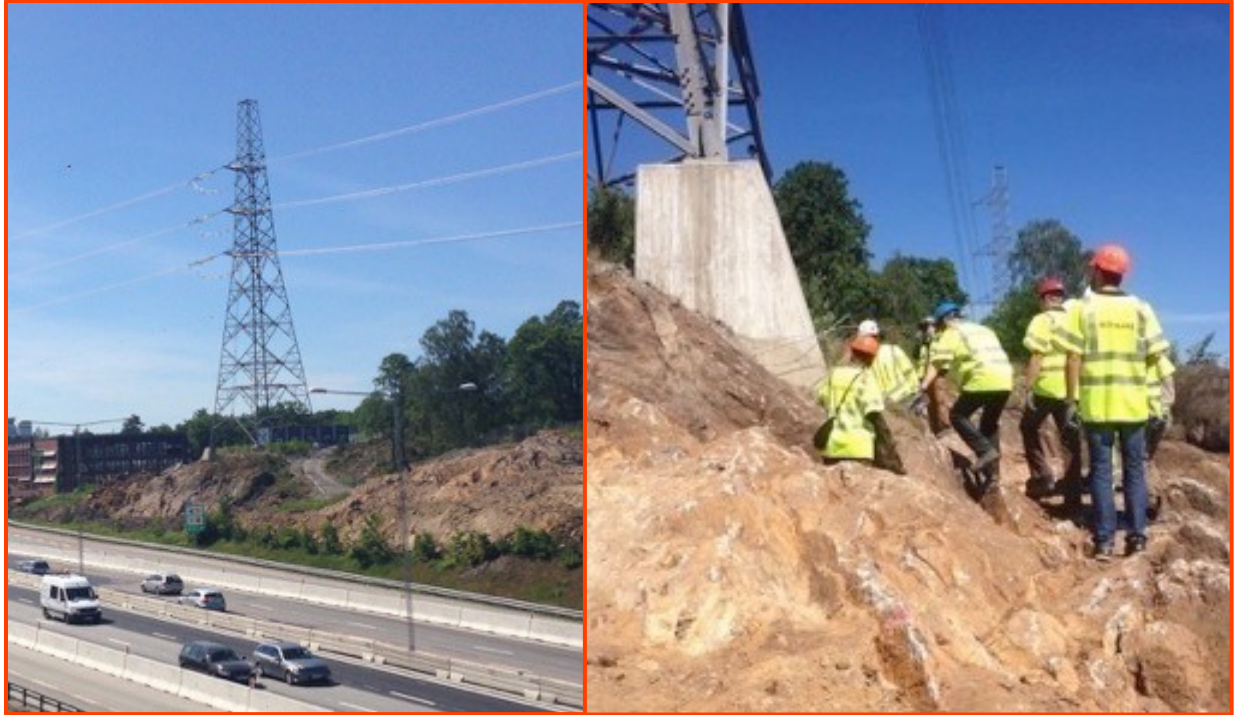
Figure 9. Power line mast near to a road to be widened. The rock mass consists of sedimentary gneiss of less good quality and with weathered sections. Photo: Lars M Hansen.

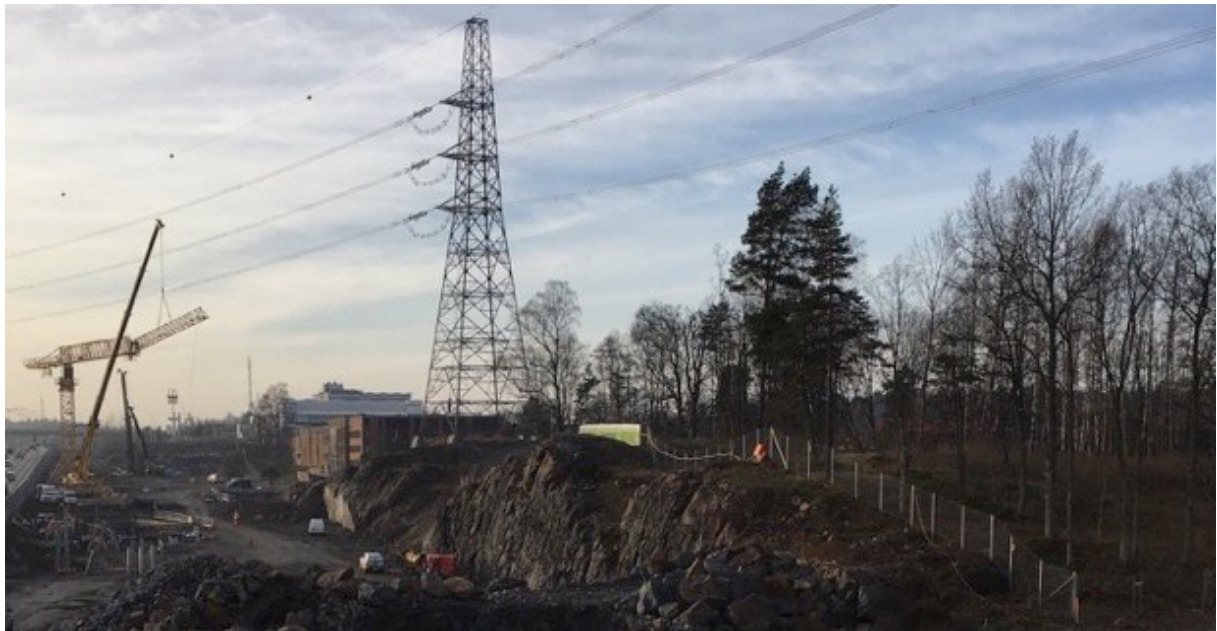
Figure 10. Same power line as in Figure 9. The planned cut was moved a few metres from the initial position and was sawn in three sections. One of the sawn sections is clearly visible to the left of and below the mast. Photo: Lars M Hansen.

In order to minimize any disturbance during rock excavation, wire sawing (Figure 10) was used to create a slot, in order to facilitate the escape of blasting gases and prevent them from penetrating and opening other fractures that could cause an unacceptably large damage zone. Outside the picture is another mast that may be affected during the widening of the E4 / E20 (Figure 11). Slots have also been generated by wire sawing, but at the time of writing, the rock mass has not yet been excavated, since minor settlements have occurred that indicate the need for the installation of additional reinforcement.

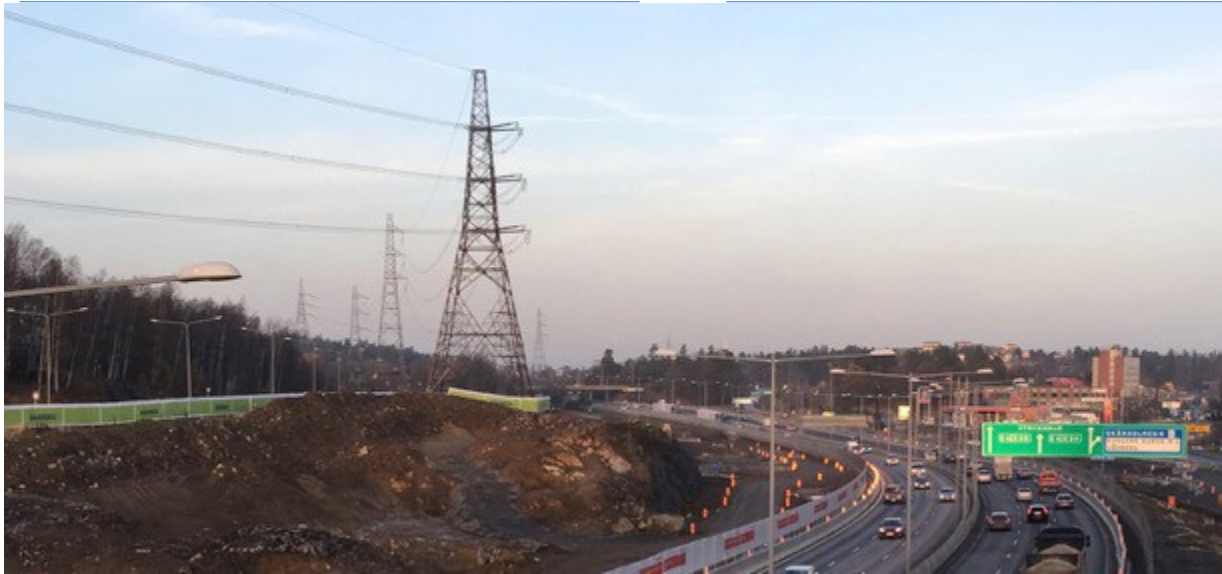
Figure 11. Power cable mast founded on rock. Along the Skärholm road and along the E4 / E20 there are planar structures with unfavourable orientations for stability (see Figure 8) and sliding of the same dimension as shown in Figure 7 can cause major damage. Therefore, rock excavation is carried out very carefully, and continuous measurements are made of the foundations to determine whether movement occurs. Photo: Lars M Hansen.

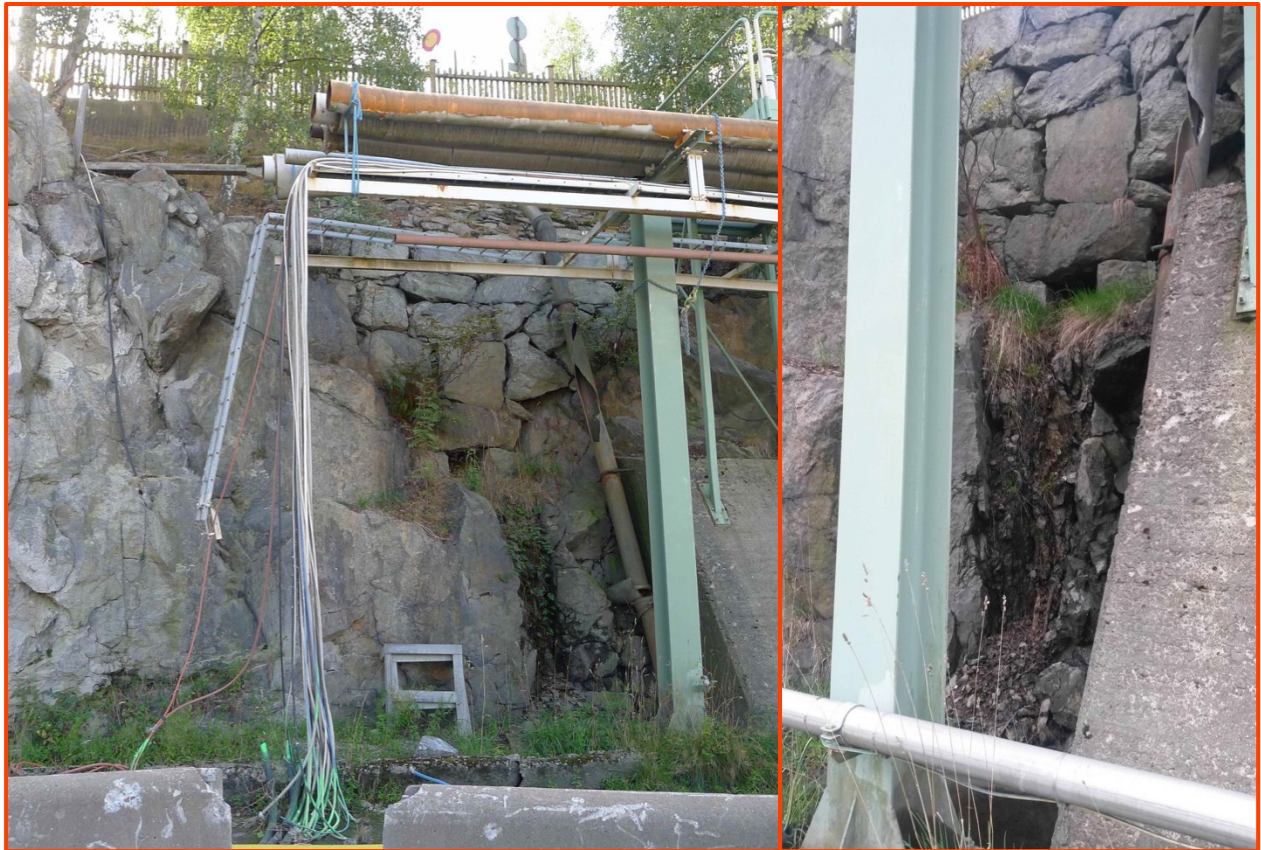
Figure 12. Hjorthagen. Fracture zone indicated on the Construction Geology Map. Overview and close-up. Photo: Sofie Eskilander, Golder.

The topographic lineaments, "fracture zones" and "crush zones" shown on the construction geological map of Stockholm (Stockholm City, Technical Office) do not always mean that there is any major zone with an influence on stability, as has been demonstrated in tunnels and open shafts. At Hjorthagen there is a topographic lineament along Rådjursstigen, which is due to an approximately 1 m wide zone with crushed rock (Figure 12). At Riddarholmen a "crush zone", which also constitutes a topographic lineament, has been found to be a fracture zone of only about 0.5 m width (Figure 13). These two examples show that the indicated fracture zones and crush zones need to be reviewed since a crush zone is usually considered more extensive than a fracture zone by a design engineer or contractor. Suggestions on how this can be done are included in the section on continuous updating.

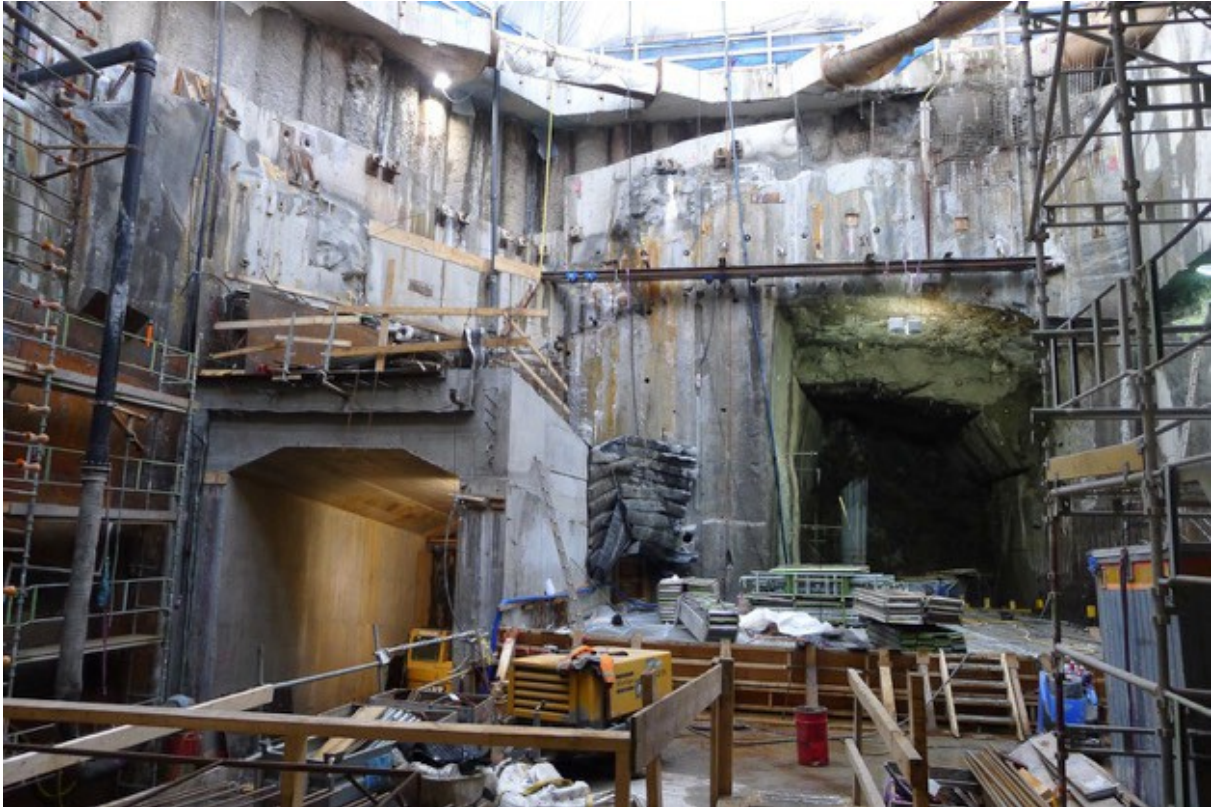
Figure 14. Riddarholmen. Excavation in bedrock, isolated from Riddarfjärden's water with the help of secant pile walls (concrete diaphragm/concrete bored pile wall) which are seen at the top of the road in the photo. Careful rock excavation is being performed by wire sawing when the rock cover is small. A depression in the rock surface above the concrete tunnel has been filled with concrete. The depression is due to an approximately 0,5 m wide fracture zone (Figure 13), which is oriented NW with a dip to the SW. Photo: Anja Olsson, Golder.

For several ongoing projects, construction results in relatively high rock cuttings next to existing facilities (eg. Förbifart Stockholm at Smista-Skärholmen-Kungens Kurva) and several rock cuttings have been generated adjacent to buildings (e.g. Idrottshögskolan, Karolinska sjukhuset and Musikhögskolan) and also water, for example, at Riddarholmen (Figure 14). At

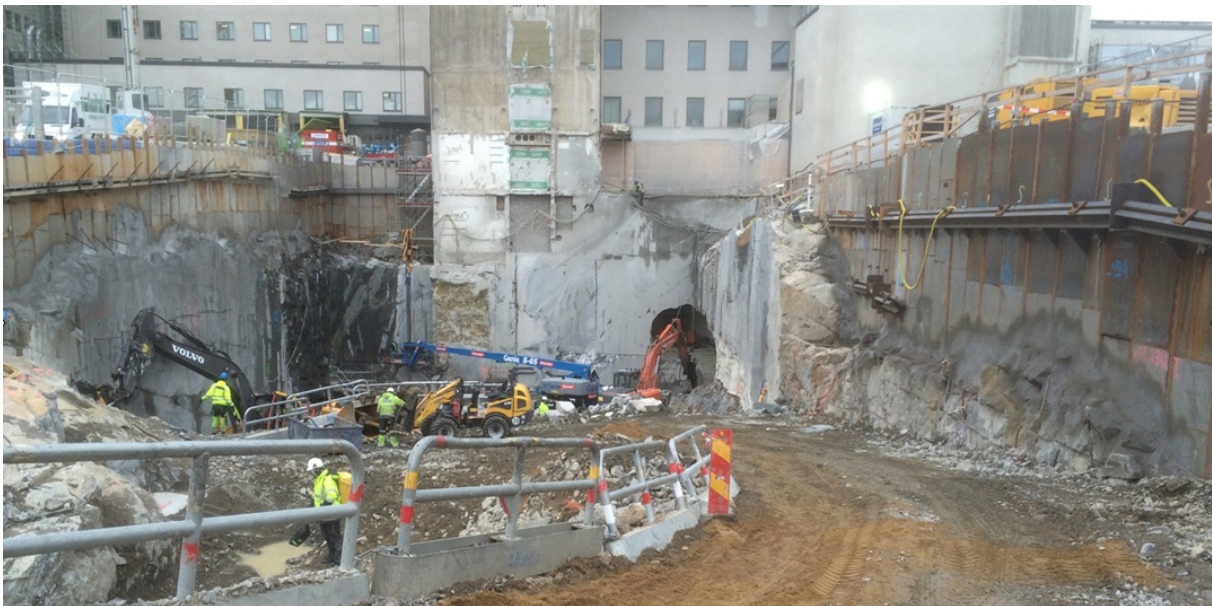
Figure 15. Södersjukhuset. Wire sawn 10 m high rock walls next to existing buildings. Prior to sawing, rock reinforcement has been installed in the form of a long bolt set from the top of the planned cut. Photo: Jörgen Theander, Golder.

Södersjukhuset excavation is currently underway as well as installation of rock reinforcement and wire sawing for vertical cuttings and tunnels (Figure 15, 16 and 17).

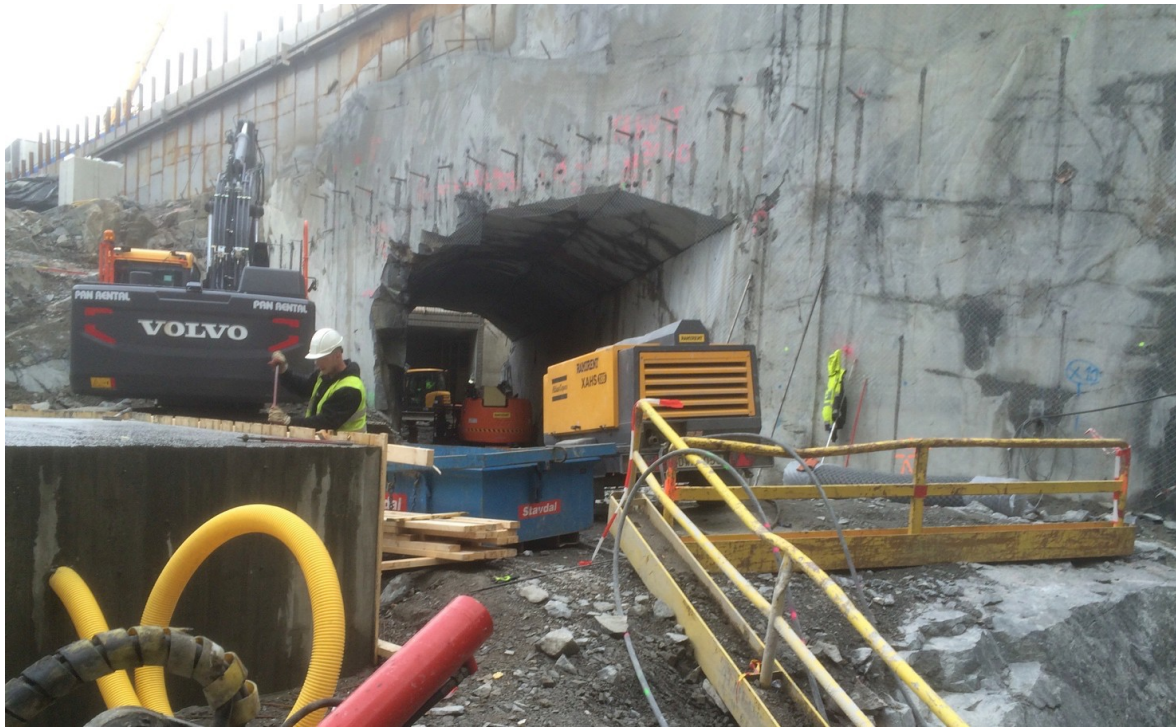
Figure 16. Tunnel with limited rock cover. The tunnel is reinforced above the planned roof line before rock excavation and the contour is wire sawn to prevent explosive gases penetrating rock fractures to crack and causing an excessive damage zone in the rock around the tunnel. Photo: Jörgen Theander, Golder.

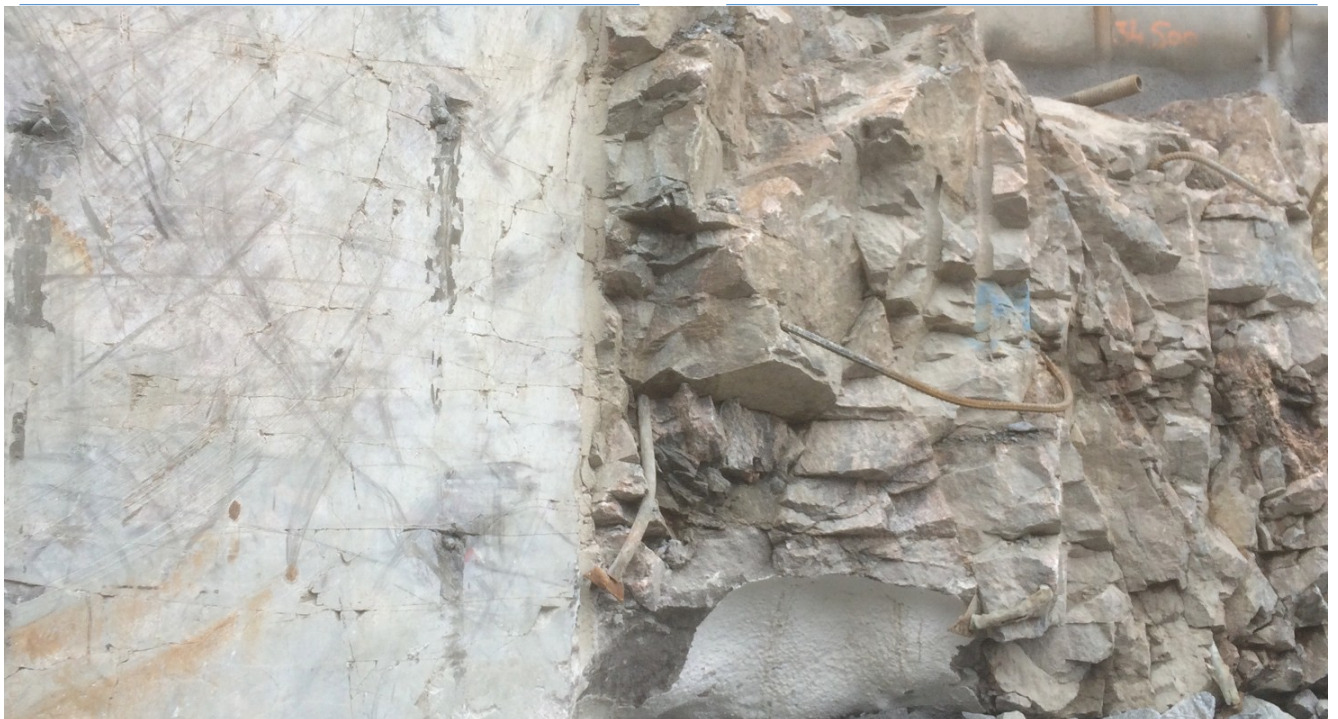
Figure 17. Comparison of a sawn and blasted rock mass, where the sawn surface also needs to be reinforced. A sawn surface can be treacherous and attention is required since the fractures do not appear as clearly. Photo: Jörgen Theander, Golder.

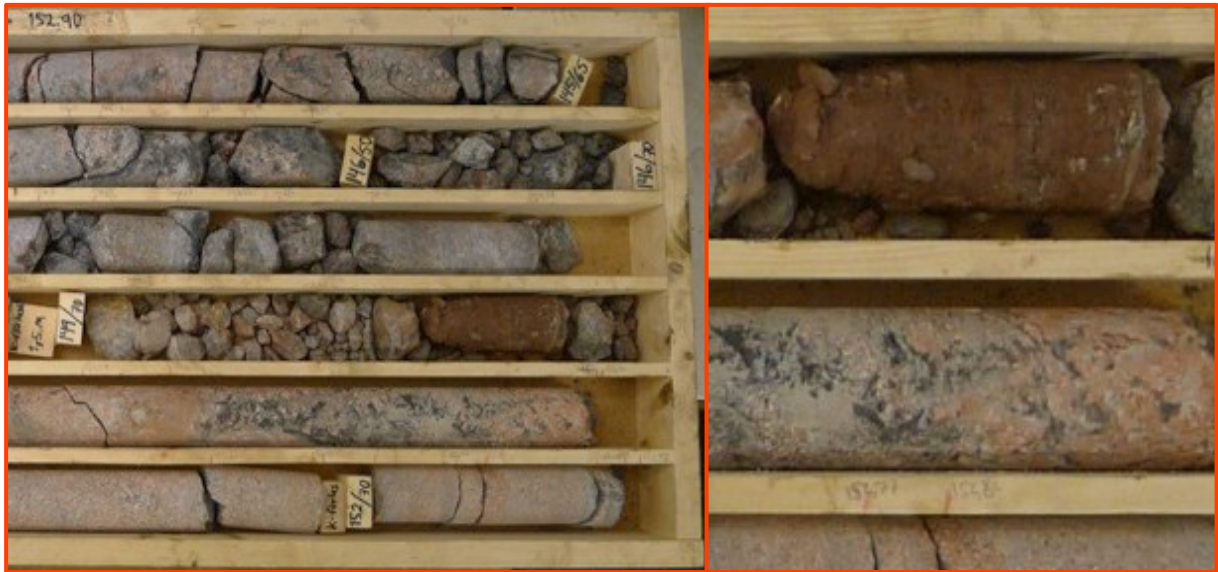
Figure 19. Drill core from core drilling through the Söderström fault at Slussen. Core-loss of approximately 2.5 m spread over two drill runs is believed to be due to swelling clay. A minor amount of such clay was found in the brown section of altered rock, and exhibited a 150 kPa swelling pressure (Clarín & Clark 2015). The missing clay may be assumed to have a similar swelling capacity.

At Slussen and farther east to Stadsgårdskajen, three cored drill holes have been bored (13GA01 for Stockholm City as well as KB01 and 13VEC06 for the City Link project), which indicate a distance of about 50-100 m with fractured rock, along and under Stadsgårdskajen, with several indicators of movement such as clay alteration, slickensides and crushed rock that get worse northwards with drill core losses that quite abruptly go over to better rock (Figure 19). In connection with the drilling of 13GA01, at the transition from very bad to better rock, under Stadsgårdskajen, more than 2.5m of drill core was flushed away with the drilling water. This material probably consisted of swelling clay, which could be detected from a bit of altered rock from the same core (Clarín & Clark, 2015).

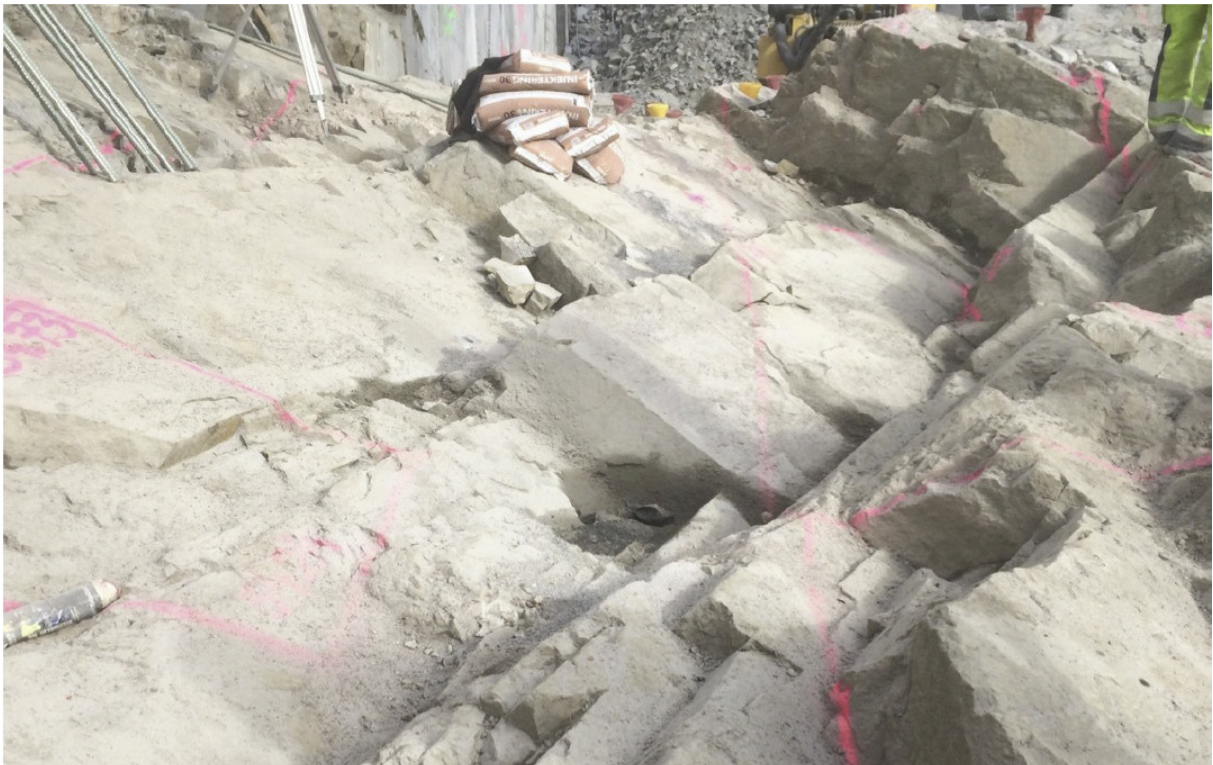
Figure 20. Southerly dipping fractures at Södersjukhuset. Photo: Lars Bergkvist, Golder.

Fractures with slickenlines dipping to the south have been observed at Södersjukhuset (Figure 20), but the direction of movement is not certain. Even in a tunnel for Citybanan at Söder Mälarstrand (Figure 21) there are fractures with clay-altered surfaces and with dips to the south, and outside the quay there is a zone with a width of 50 m (Olsson et al. 2014).

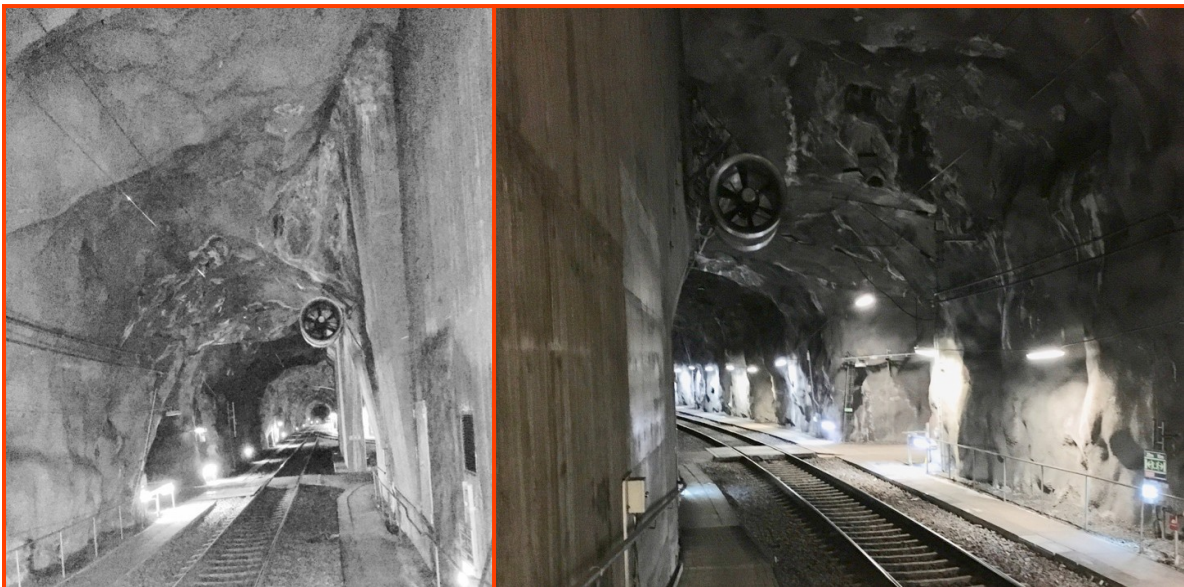
Figure 28. Arlandabanan, southern end of Arlanda N station (terminal 5). Here there was a movement, -heave in the roof, in connection with blasting. The crack that occurred between the rock pillar and the overlying rock mass cannot be seen in the picture as it is covered with shotcrete and the cast concrete pillar. Photo: Lars M Hansen.

During the rock excavation of the Northern Station at Terminal 5, the rock stresses caused a lifting of the roof, so that at the transition between the station and the track tunnels, a gap of about 5 mm was formed between the rock pillar and roof, which showed that the station rock cavern had favourable stability conditions (Ljunggren & Chang 1998).

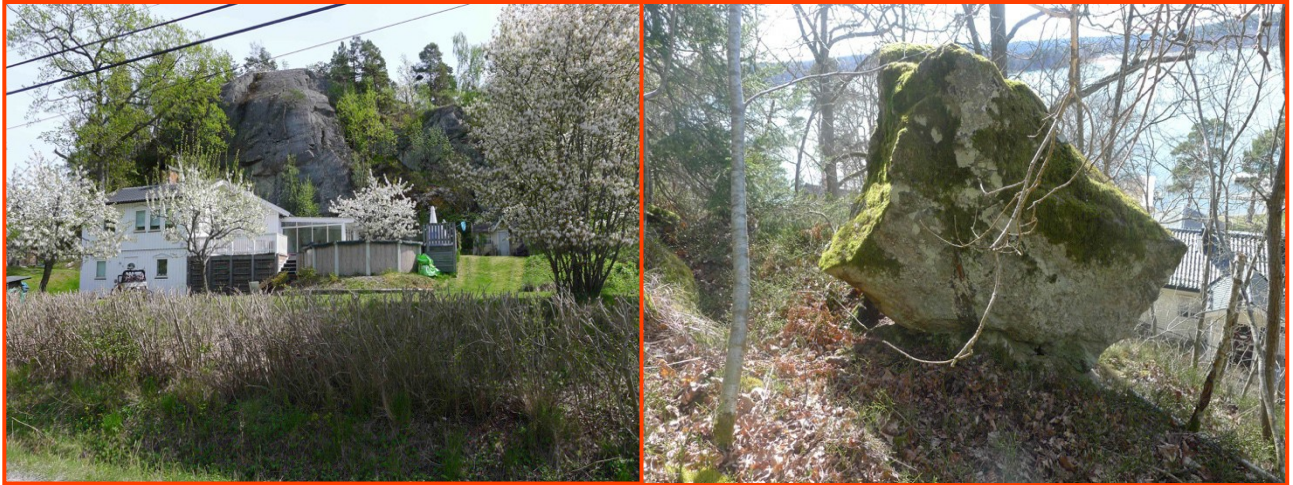
Figure 29. A house below a steep rock slope, and a large block on the slope edge. Photo Anja Olsson, Sofie Eskilander.

In many places in the Stockholm area there are high natural rock slopes in the vicinity of houses (Figure 29). Tyresö is an example where rock falls have occurred. Risk analyses for such events can be performed using software to assess the likelihood of how far from the slope or cliff, blocks

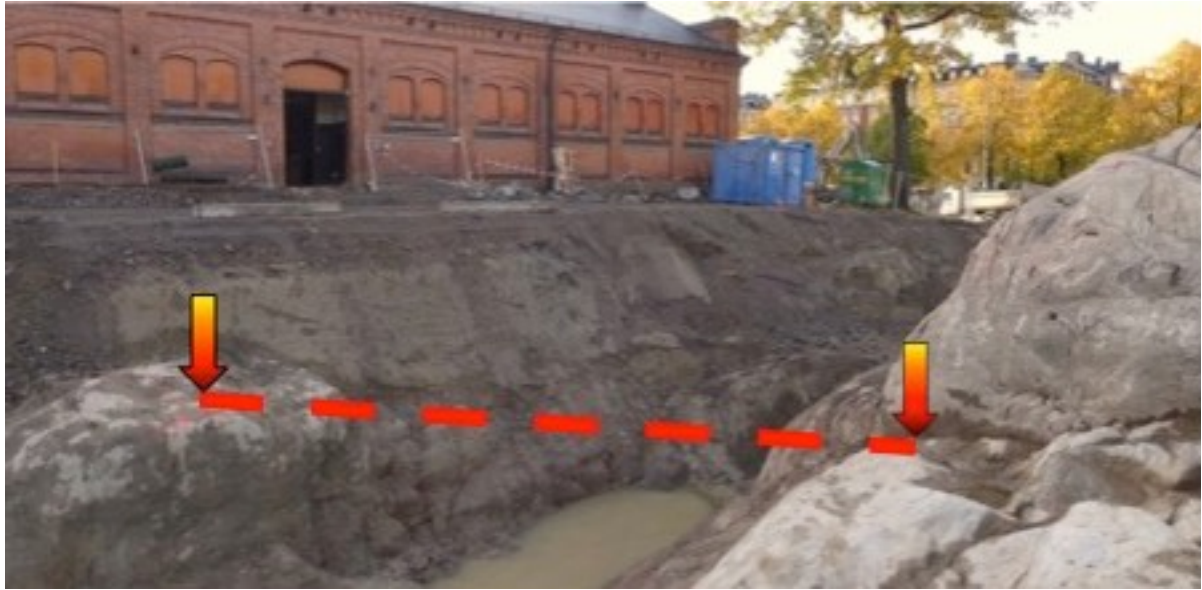
Figure 31. Example of how bedrock probing can give rise to a misleading interpretation. When probing was performed at the arrows (cc about 10 m) the depression was missed. Photo: Edward Runslätt, Golder.

When planning and designing construction work, exploration is often performed to investigate the soil's technical properties and the depth to the bedrock. The expected depth controls the spacing of the investigations performed. However, there are always uncertainties: Figure 31 and Figure 32 show examples of this from a building site on Northern Östermalm.

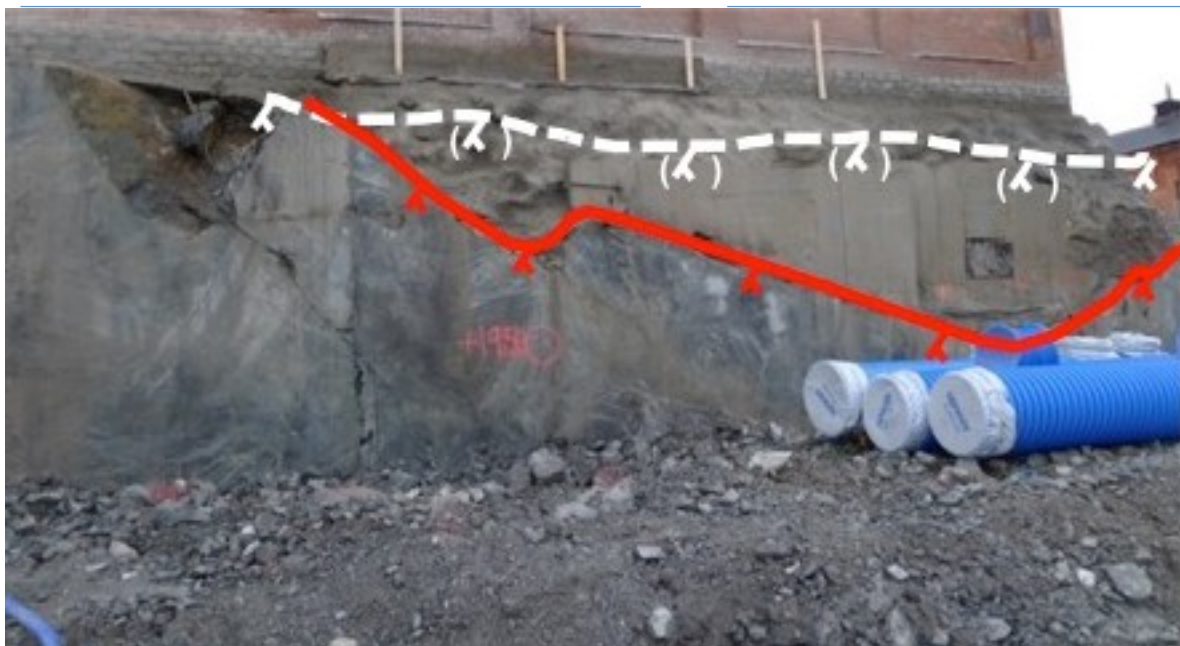
Figure 32. The figure shows the interpreted (white) bedrock profile based on probes and the real (red) bedrock profile, as well as the supporting walls that needed to be built. Photo: Edward Runslätt, Golder.

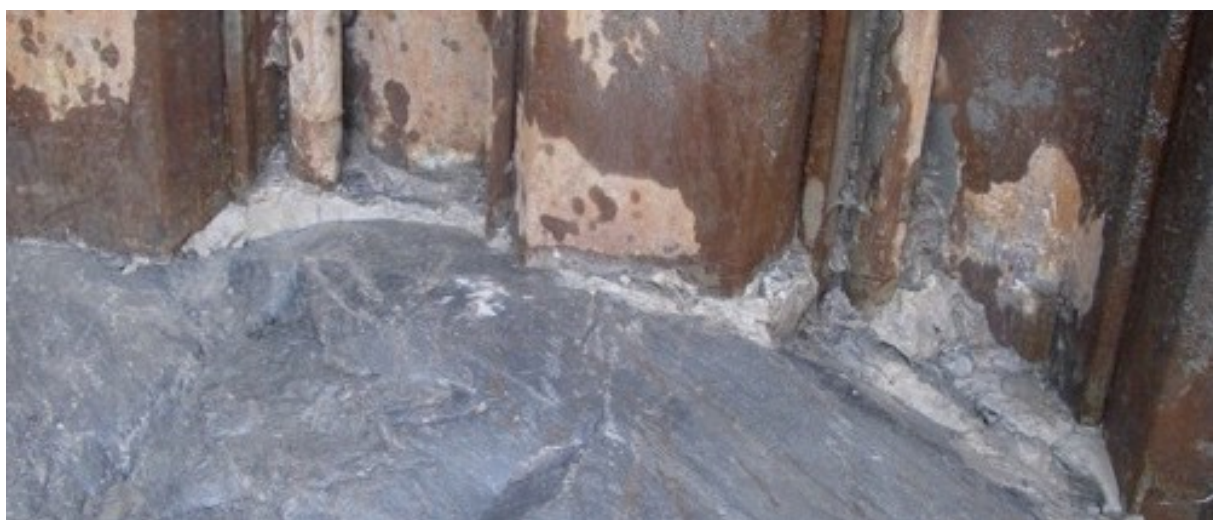
Figure 34. Grout at the contact between the sheet pile wall and the bedrock. Photo Mikael Creütz, Golder.

how different methods are used in the geological formations. The contact between wall and rock is shown in Figure 34 and Figure 35.
